## General Information

<b>Make</b>	Toyota	<b>Model</b>	Rush
<b>YOM</b>	2022	<b>Mileage</b>	123
<b>Registration No.</b>	S8M870	<b>Chassis No.</b>	123456789
<b>CC</b>	1.5	<b>Transmission</b>	A/T
<b>Fuel Type</b>	Gas	<b>Type of Body</b>	SUV
<b>Colour</b>	Black

## Body / Panel Condition

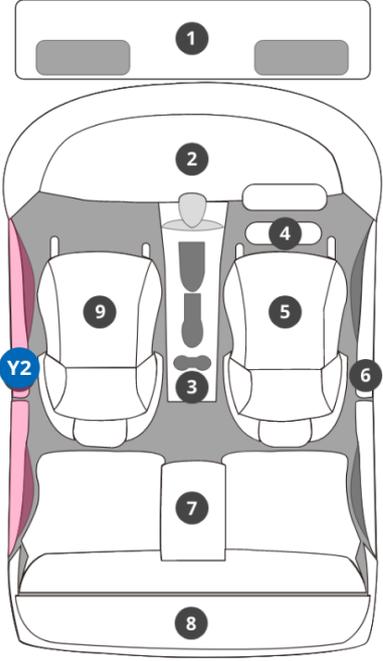
<b>Interior Evaluation :</b> <span style="float: right; color: red; font-weight: bold;">A</span>	<b>Exterior Evaluation :</b> <span style="float: right; color: red; font-weight: bold;">A</span>

<p><b>a</b> : Cut, Fray <b>d</b> : Loose, Deformed <b>k</b> : Animal Hair <b>s</b> : Smell <b>t</b> : Cigarette Burns <b>x</b> : Defective <b>y</b> : Stain</p>

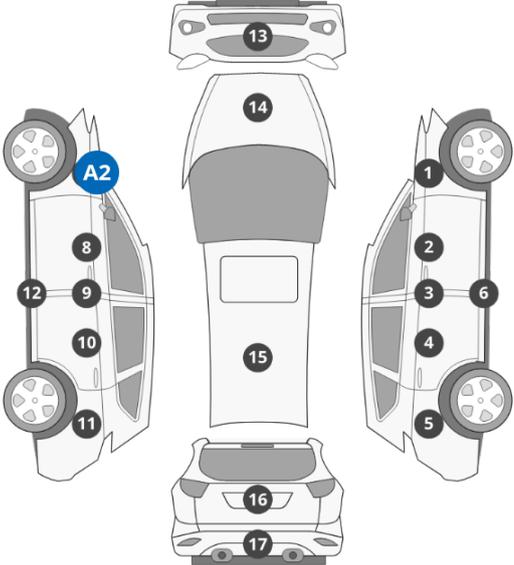
<p><b>A</b> : Scratch <b>AU</b> : Scratch &amp; Dent <b>B</b> : Modified <b>C</b> : Corrosion <b>G</b> : Stone chip <b>P</b> : Faded <b>S</b> : Rust <b>SC</b> : Rust &amp; Corrosion <b>U</b> : Dent <b>X</b> : Defective <b>Y</b> : Crack, Gap</p>
<b>Remarks</b> (L) Front Trim - Grime - Small	<b>Remarks</b> (L) Front Fender, Molding - Scratch - Small
<b>Frame Evaluation :</b> <span style="float: right; color: red; font-weight: bold;">A</span>	<b>Functional Evaluation :</b> <span style="float: right; color: red; font-weight: bold;">A</span>
