## General Information

| Make | Toyota | Model | Veloz |
| YOM | 2023 | Mileage | 20,658 |
| Registration No. | NHJ8066 | Chassis No. | MHFAB1BY9P3058855 |

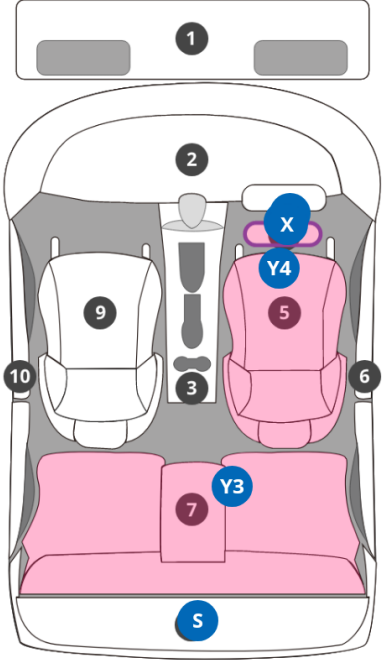
| <b>Interior Evaluation :</b> <span style="color: red; font-weight: bold;">C</span> | <b>Exterior Evaluation :</b> <span style="color: red; font-weight: bold;">E</span> |
| <p><b>Remarks</b></p> <p>Rear Seat - Grime - Medium / Overall Interior - Smell - Yes / (R) Front Seat - Grime - Large / Mat Other - Missing - Yes / (L) Front Floor Mat - Missing - Yes / (R) Front Floor Mat - Missing - Yes</p> | <p><b>Remarks</b></p> <p>(R) Front Fender, Molding - Scratch &amp; Dent - Medium / (R) Mirror - Faded(Color, Gloss) - Yes / (R) Mirror - Scratch - Small / (R) Front Door, Molding - Scratch &amp; Dent - Medium / (R) Rear Door, Molding - Scratch - Small / (R) Rear Fender, Molding - Scratch - Small / Rear Bumper, Lamps, Panels - Scratch - Small / Trunk Hood, Rear Gate - Scratch &amp; Dent - Small / (L) Rear Fender, Molding - Repair mark - Yes / (L) Rear Fender, Molding - Scratch &amp; Dent - Medium / (L) Front Door, Molding - Repair mark - Yes / (L) Rear Door, Molding - Repair mark - Yes / (L) Rear Door, Molding - Scratch &amp; Dent - Large / (L) Front Door, Molding - Scratch &amp; Dent - Large / (L) Mirror - Scratch - Small / (L) Front Fender, Molding - Repair mark - Yes / (L) Front Fender, Molding - Scratch &amp; Dent - Large / Front Bumper, Grille, Lamps - Scratch &amp; Dent - Large</p> |
