## General Information

| Make | Toyota | Model | Vios |
| YOM | 2024 | Mileage | 25,093 |
| Registration No. | NFR2605 | Chassis No. | PA1B18F30R4252685 |

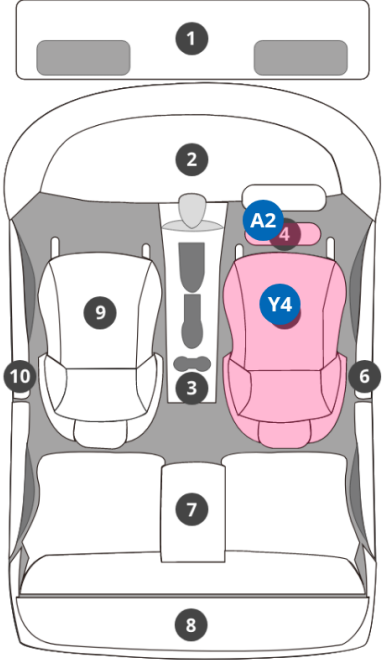
| Interior Evaluation : <span style="color: red;">C</span> | Exterior Evaluation : <span style="color: red;">E</span> |
|---|---|
| <b>Remarks</b><br>(R) Front Seat - Grime - Large / (L) Front Floor Mat - Cut, Crack - Small | <b>Remarks</b><br>(R) Rear Door - Repair Traces - Yes / (L) Rear Door, Molding - Scratch & Dent - Large / (L) Rear Fender, Molding - Scratch & Dent - Large / Trunk Hood, Rear Gate - Scratch & Dent - Large / Rear Bumper, Lamps, Panels - Scratch & Dent - Large / (R) Rear Fender, Molding - Scratch & Dent - Large / (R) Step, In-panel, Side Spoiler - Scratch & Dent - Large / Front Bumper, Grille, Lamps - Scratch - Medium / (R) Front Door, Molding - Scratch - Medium / (R) Rear Door, Molding - Scratch - Medium / (L) Step, In-panel, Side Spoiler - Scratch & Dent - Small / (L) Front Door, Molding - Scratch & Dent - Small |
