## General Information

| Make | Toyota | Model | Vios |
| YOM | 2023 | Mileage | 28,964 |
| Registration No. | BAF3250 | Chassis No. | PA1B18F36P4204380 |

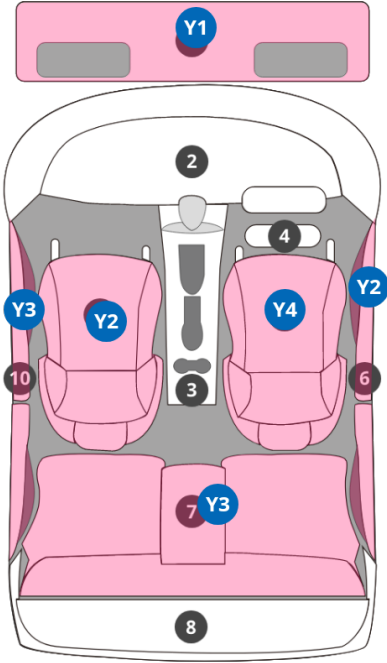
| Interior Evaluation : <span style="color: red;">C</span> | Exterior Evaluation : <span style="color: red;">C</span> |
| <p><b>Remarks</b><br/>(L) Front Trim - Grime - Medium / (R) Front Seat - Grime - Large / Rear Seat - Grime - Medium / (L) Front Seat - Grime - Small / (R) Front Trim - Grime - Small / Ceiling - Grime - Minimal</p> | <p><b>Remarks</b><br/>(R) Front Door - Repair Traces - Yes / (R) Rear Fender - Repair Traces - Yes / (R) Rear Door - Repair Traces - Yes / Rear Bumper, Lamps, Panels - Scratch - Large / Trunk Hood, Rear Gate - Scratch &amp; Dent - Small / (L) Rear Fender, Molding - Scratch - Minimal / (L) Rear Door, Molding - Scratch - Minimal / (L) Front Door, Molding - Scratch - Small / (L) Front Fender, Molding - Scratch - Minimal / Front Bumper, Grille, Lamps - Scratch - Medium / (R) Front Fender, Molding - Scratch &amp; Dent - Small / (R) Mirror - Scratch - Minimal / (R) Front Door, Molding - Dent - Small / (R) Rear Door, Molding - Scratch - Small / (R) Rear Fender, Molding - Dent - Small / Bonnet, Headlight - Scratch - Minimal</p> |

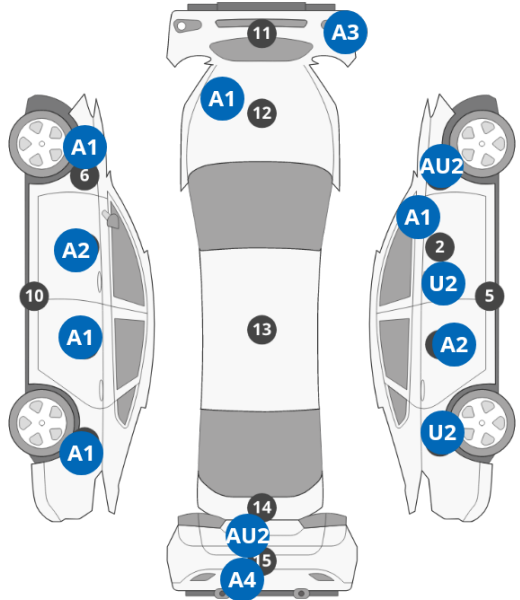
| Inspector Notes |
|---|
| with LTO plate/with spare tire/with jack and incomplete tools/with warranty booklet/No reverse camera/trunk room No cover/right side front door and rear door and rear fender was repainted |
