## General Information

<b>Make</b>	Toyota	<b>Model</b>	Vios
<b>YOM</b>	2025	<b>Mileage</b>	8,454
<b>Registration No.</b>	DBQ1999	<b>Chassis No.</b>	PA1B18F36R4267644
<b>CC</b>	1.3	<b>Transmission</b>	CVT
<b>Fuel Type</b>	Gas	<b>Type of Body</b>	Sedan
<b>Colour</b>	Silver

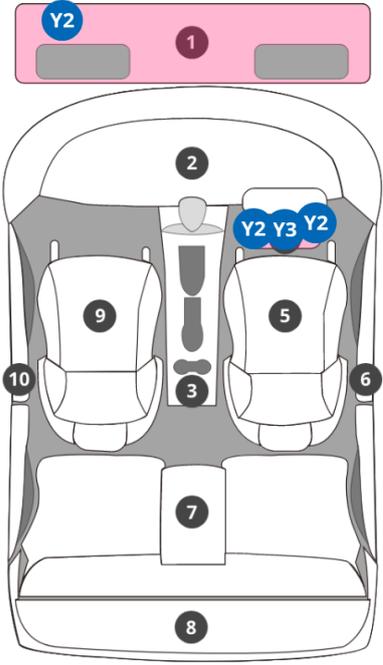
<b>Interior Evaluation :</b> <span style="float: right;"><b>B</b></span>	<b>Exterior Evaluation :</b> <span style="float: right;"><b>B</b></span>

<p><b>a</b> : Cut, Fray <b>d</b> : Loose, Deformed <b>k</b> : Animal Hair <b>s</b> : Smell <b>t</b> : Cigarette Burns <b>x</b> : Defective <b>y</b> : Stain</p>

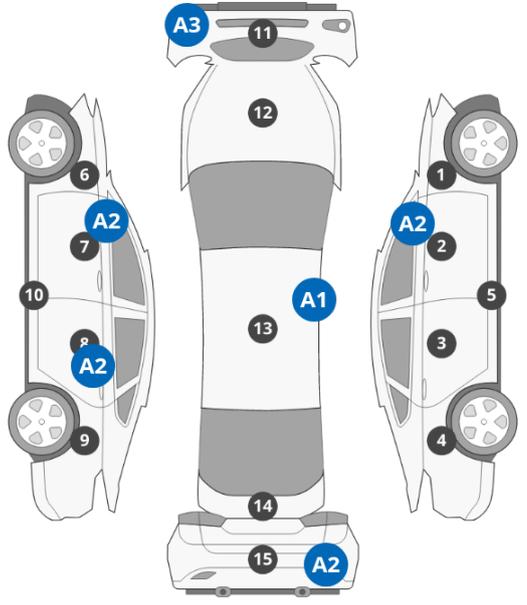
<p><b>A</b> : Scratch <b>AU</b> : Scratch &amp; Dent <b>B</b> : Modified <b>C</b> : Corrosion <b>G</b> : Stone chip <b>P</b> : Faded <b>S</b> : Rust <b>SC</b> : Rust &amp; Corrosion <b>U</b> : Dent <b>X</b> : Defective <b>Y</b> : Crack, Gap</p>
<p><b>Remarks</b> Ceiling - Grime - Small / (R) Front Floor Mat - Grime - Small / Mat Other - Grime - Medium / (L) Front Floor Mat - Grime - Small</p>	<p><b>Remarks</b> (L) Rear Fender - Repair Traces - Yes / (L) Mirror - Scratch - Small / Front Bumper, Grille, Lamps - Scratch - Medium / (R) Mirror - Scratch - Small / Roof - Scratch - Minimal / (L) Rear Door, Molding - Scratch - Small / Rear Bumper, Lamps, Panels - Scratch - Small</p>
