## General Information

| Make | Toyota | Model | Vios |

## Body / Panel Condition

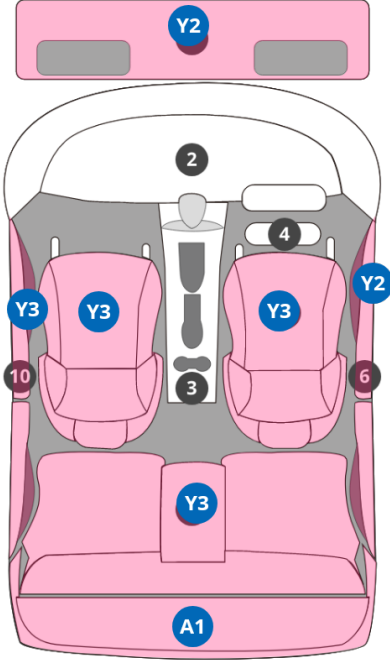
| Interior Evaluation : <b>C</b> | Exterior Evaluation : <b>D</b> |
| <p><b>Remarks</b><br/>(L) Front Seat - Grime - Medium / (L) Front Trim - Grime - Medium / (R) Front Seat - Grime - Medium / (R) Front Trim - Grime - Small / Rear Seat - Grime - Medium / Ceiling - Grime - Small / Trunk Room - Worn, Scratch, Cut, Crack - Minimal</p> | <p><b>Remarks</b><br/>(R) Rear Door, Molding - Repair mark - Yes / Trunk Hood, Rear Gate - Repair mark - Yes / Rear Bumper, Lamps, Panels - Repair mark - Yes / (L) Mirror - Scratch - Minimal / Front Bumper, Grille, Lamps - Repair mark - Yes / Front Bumper, Grille, Lamps - Scratch &amp; Dent - Large / (R) Mirror - Scratch - Minimal / (R) Rear Door, Molding - Scratch - Small / Rear Bumper, Lamps, Panels - Scratch - Large / Trunk Hood, Rear Gate - Dent - Small / (L) Rear Door, Molding - Dent - Small / (L) Front Fender, Molding - Repair mark - Yes / (L) Front Fender, Molding - Dent - Small / (R) Front Door, Molding - Scratch - Minimal / (R) Rear Fender, Molding - Repair mark - Yes / (L) Rear Fender, Molding - Scratch - Minimal / Roof - Scratch - Minimal / Bonnet, Headlight - Dent - Minimal</p> |
