## General Information

| Make | Toyota | Model | Vios |

## Body / Panel Condition

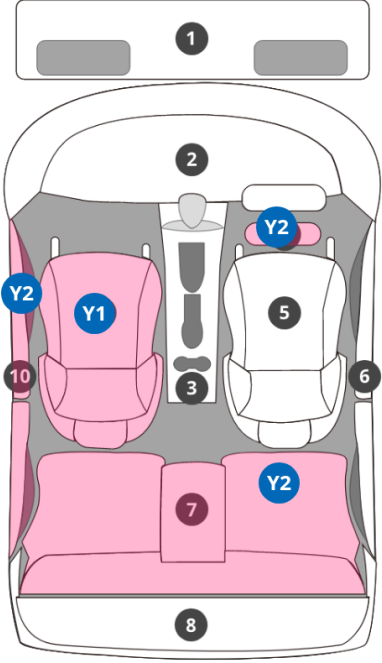
| <b>Remarks</b><br>(L) Front Floor Mat - Grime - Small / Rear Seat - Grime - Small / (L) Front Seat - Grime - Minimal / (L) Front Trim - Grime - Small | <b>Remarks</b><br>Bonnet, Headlight - Scratch - Minimal / (L) Front Fender, Molding - Dent - Small / (L) Front Door, Molding - Scratch - Minimal / (L) Rear Door, Molding - Scratch - Minimal / Rear Bumper, Lamps, Panels - Scratch - Small / Trunk Hood, Rear Gate - Scratch - Minimal / (R) Front Door, Molding - Scratch - Minimal / (L) Rear Fender, Molding - Scratch - Minimal |
