## General Information

| Make | Toyota | Model | Vios |
| YOM | 2021 | Mileage | 135,274 |
| Registration No. | NEV1909 | Chassis No. | PA1B18F30M4155611 |

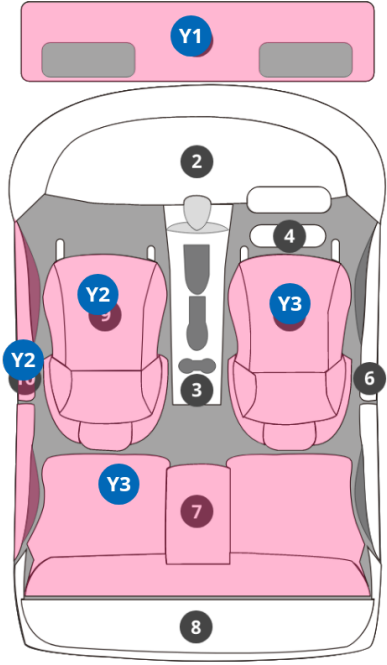
| Interior Evaluation : <span style="color: red;">C</span> | Exterior Evaluation : <span style="color: red;">B</span> |
| <b>Remarks</b><br>(R) Front Seat - Grime - Medium / Rear Seat - Grime - Medium / (L) Front Seat - Grime - Small / (L) Front Trim - Grime - Small / Ceiling - Grime - Minimal / Overall Interior - Worn as per age - Yes | <b>Remarks</b><br>Roof - Dent - Minimal / (L) Rear Door, Molding - Scratch & Dent - Minimal / (L) Rear Fender, Molding - Dent - Minimal / Trunk Hood, Rear Gate - Scratch - Minimal / Rear Bumper, Lamps, Panels - Dent - Small / (R) Front Door, Molding - Scratch & Dent - Small / (R) Rear Door, Molding - Scratch - Minimal / (R) Rear Fender, Molding - Scratch - Minimal / (R) Mirror - Scratch - Minimal / (L) Mirror - Scratch - Minimal / (L) Front Door, Molding - Scratch - Small / (L) Front Fender, Molding - Dent - Small / Front Bumper, Grille, Lamps - Scratch - Small / Bonnet, Headlight - Scratch - Minimal |
