## General Information

| Make | Toyota | Model | Vios |
| YOM | 2024 | Mileage | 18,168 |

## Body / Panel Condition

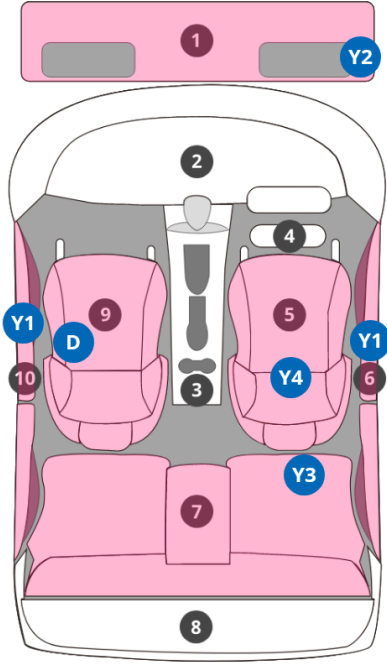
| Interior Evaluation : <span style="color: red;">C</span> | Exterior Evaluation : <span style="color: red;">C</span> |
|---|---|
| <p><b>Remarks</b><br/>(R) Front Seat - Grime - Large / (L) Front Seat - Worn - Yes / Rear Seat - Grime - Medium / (R) Front Trim - Grime - Minimal / (L) Front Trim - Grime - Minimal / Ceiling - Grime - Small</p> | <p><b>Remarks</b><br/>(R) Rear Door, Molding - Scratch - Medium / (R) Rear Fender, Molding - Scratch - Small / Rear Bumper, Lamps, Panels - Scratch - Small / Trunk Hood, Rear Gate - Dent - Small / (L) Rear Door, Molding - Scratch &amp; Dent - Minimal / (L) Step, In-panel, Side Spoiler - Scratch &amp; Dent - Large / (L) Front Door, Molding - Scratch - Minimal / (L) Front Fender, Molding - Scratch &amp; Dent - Small / Member (Bolted) - Dent - Yes / Front Bumper, Grille, Lamps - Scratch &amp; Dent - Medium</p> |

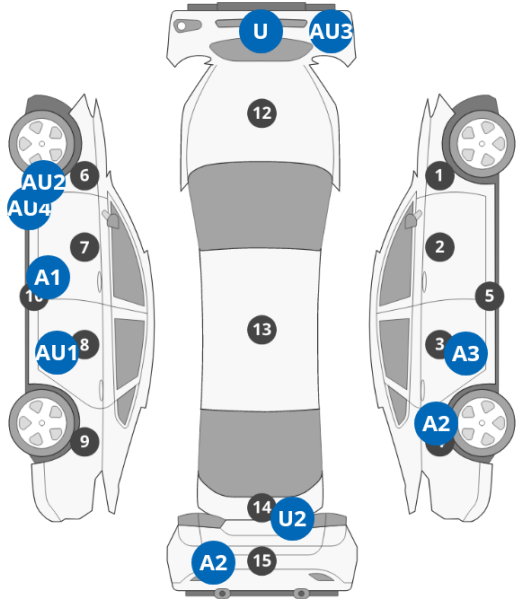
| Inspector Notes |
|---|
| with warranty booklet, with jack, no tools, with spare tire, with LTO plate, scratches on tail light j |
