## General Information

| Make | Toyota | Model | Vios |

## Body / Panel Condition

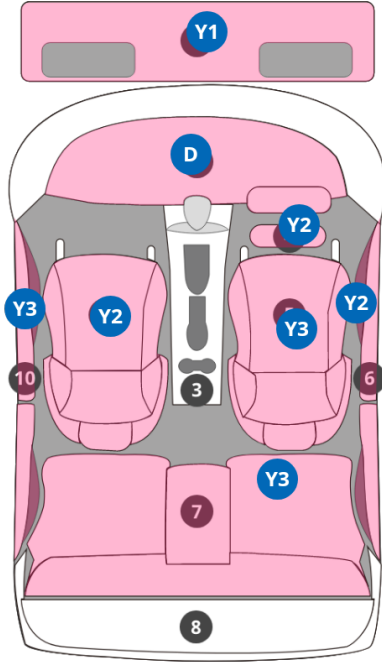
| Interior Evaluation : <span style="color: red;">C</span> | Exterior Evaluation : <span style="color: red;">C</span> |
| <b>Remarks</b><br>(R) Front Seat - Grime - Medium / (R) Front Trim - Grime - Small / Rear Seat - Grime - Medium / (L) Front Trim - Grime - Medium / (L) Front Seat - Grime - Small / (L) Front Floor Mat - Grime - Small / Dashboard - Traces of Adhesive Tape - Yes / Ceiling - Grime - Minimal | <b>Remarks</b><br>Trunk Hood, Rear Gate - Repair Traces - Yes / Rear Bumper, Lamps, Panels - Scratch - Medium / (R) Rear Fender, Molding - Scratch - Minimal / (R) Rear Door, Molding - Scratch - Minimal / (R) Front Door, Molding - Scratch - Small / (R) Front Fender, Molding - Scratch & Dent - Medium / Front Bumper, Grille, Lamps - Scratch - Large / Bonnet, Headlight - Scratch - Small / (L) Front Fender, Molding - Scratch - Minimal / (L) Mirror - Scratch - Minimal / (L) Front Door, Molding - Scratch - Minimal / (L) Rear Door, Molding - Scratch - Minimal / (L) Step, In-panel, Side Spoiler - Dent - Small / (L) Rear Fender, Molding - Scratch - Minimal / Trunk Hood, Rear Gate - Dent - Small |
