## General Information

| Make | Toyota | Model | Vios |
| Registration No. | CAW3096 | Chassis No. | PA1B18F33M4157532 |

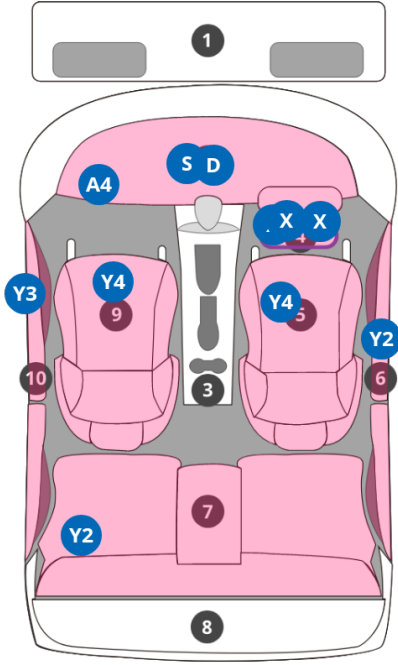
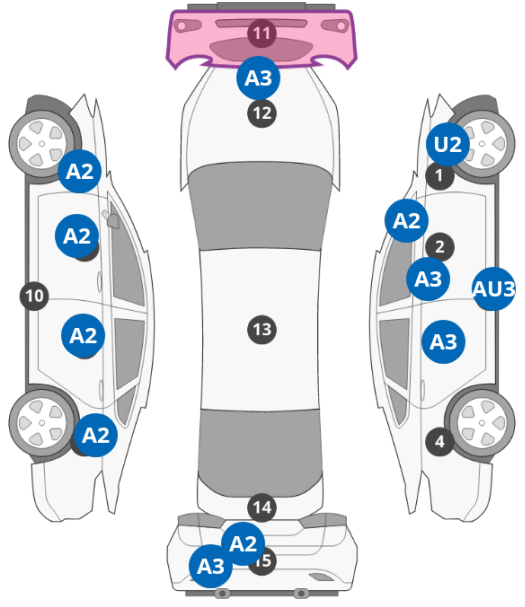
| Interior Evaluation : <b>C</b> | Exterior Evaluation : <b>D</b> |
|---|---|
| <p><b>a</b> : Cut, Fray <b>d</b> : Loose, Deformed <b>k</b> : Animal Hair <b>s</b> : Smell <b>t</b> : Cigarette Burns <b>x</b> : Defective <b>y</b> : Stain</p> | <p><b>A</b> : Scratch <b>AU</b> : Scratch &amp; Dent <b>B</b> : Modified <b>C</b> : Corrosion <b>G</b> : Stone chip <b>P</b> : Faded <b>S</b> : Rust <b>SC</b> : Rust &amp; Corrosion <b>U</b> : Dent <b>X</b> : Defective <b>Y</b> : Crack, Gap</p> |
| <b>Remarks</b><br>Steering Wheel - Worn, Peel, Crack - Large / (L) Front Seat - Grime - Large / (R) Front Seat - Grime - Large / (R) Front Floor Mat - Missing - Yes / (L) Front Floor Mat - Missing - Yes / Mat Other - Missing - Yes / Rear Seat - Grime - Small / Dashboard - Traces of Adhesive Tape - Yes / (L) Front Trim - Grime - Medium / (R) Front Trim - Grime - Small / Overall Interior - Smell - Yes | <b>Remarks</b><br>(R) Step, In-panel, Side Spoiler - Scratch & Dent - Medium / (R) Rear Door, Molding - Scratch - Medium / (R) Front Door, Molding - Scratch - Medium / (R) Mirror - Scratch - Small / Front Bumper, Grille, Lamps - Repair mark - Yes / (R) Front Fender, Molding - Dent - Small / (L) Front Fender, Molding - Scratch - Small / (L) Front Door, Molding - Scratch - Small / (L) Rear Door, Molding - Scratch - Small / (L) Rear Fender, Molding - Scratch - Small / Rear Bumper, Lamps, Panels - Scratch - Medium / Trunk Hood, Rear Gate - Scratch - Small / Bonnet, Headlight - Scratch - Medium |
