## General Information

| Make | Toyota | Model | Vios |

## Body / Panel Condition

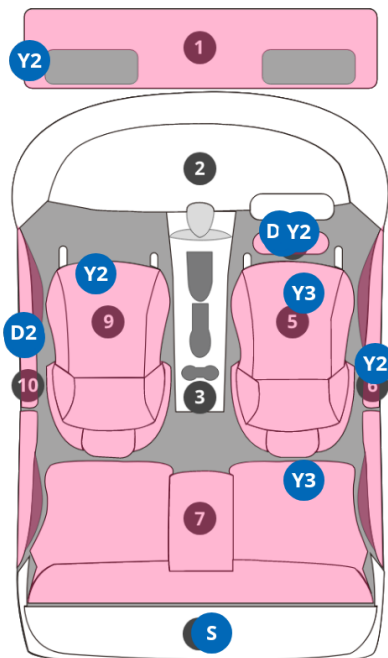
| Interior Evaluation : <span style="color: red; font-weight: bold;">C</span> | | Exterior Evaluation : <span style="color: red; font-weight: bold;">E</span> | |
| <p><b>Remarks</b></p> <p>(R) Front Seat - Grime - Medium / (L) Front Seat - Grime - Small / Rear Seat - Grime - Medium / (R) Front Trim - Grime - Small / (R) Front Floor Mat - Grime - Small / (L) Front Floor Mat - Worked - Large / (L) Front Floor Mat - Grime - Small / (L) Front Trim - Grime - Medium / (L) Front Trim - Worked - Small / Overall Interior - Smell - Yes / Ceiling - Grime - Small</p> | | <p><b>Remarks</b></p> <p>(R) Front Fender, Molding - Scratch &amp; Dent - Medium / (R) Mirror - Scratch - Minimal / (R) Front Door, Molding - Scratch - Medium / (R) Rear Door, Molding - Scratch - Small / (R) Rear Fender, Molding - Scratch - Medium / Rear Bumper, Lamps, Panels - Crack, Gap - Medium / Trunk Hood, Rear Gate - Crack, Gap - Medium / (L) Rear Fender, Molding - Scratch &amp; Dent - Small / (L) Rear Door, Molding - Scratch - Large / (L) Front Door, Molding - Scratch - Small / (L) Mirror - Scratch - Small / (L) Front Fender, Molding - Scratch &amp; Dent - Medium / Front Bumper, Grille, Lamps - Scratch &amp; Dent - Large / Bonnet, Headlight - Scratch - Minimal / Roof - Dent - Small</p> | |

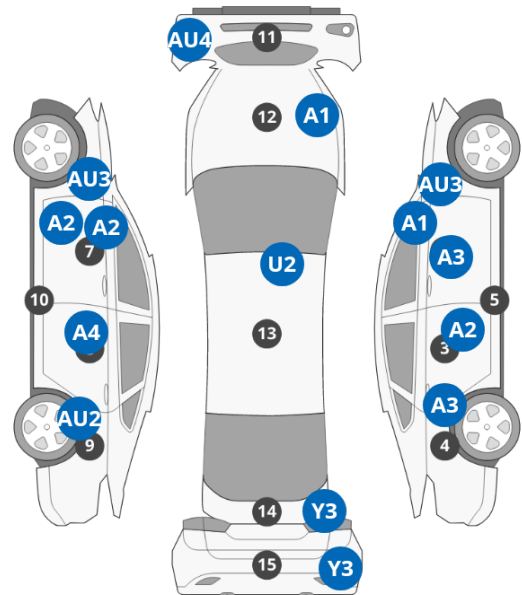
no warranty booklet, with jack, incomplete tools, with spare tire, with LTO plate, scratches on tail light, possible flooding, worn tires
