## General Information

| Make | Toyota | Model | Vios |

## Body / Panel Condition

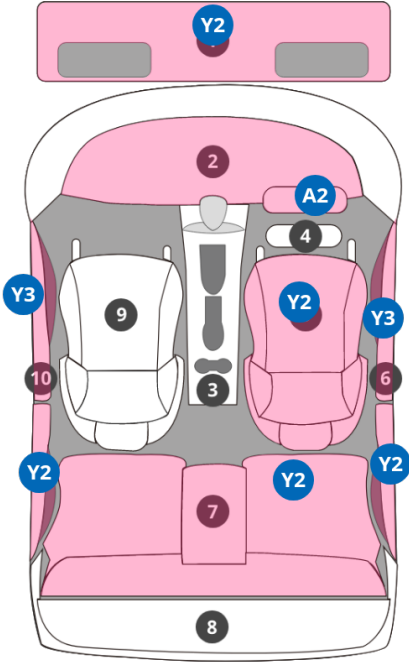
| Interior Evaluation : <b>C</b> | Exterior Evaluation : <b>E</b> |
| <p><b>Remarks</b></p> <p>Ceiling - Grime - Small / (R) Front Seat - Grime - Small / (L) Front Trim - Grime - Medium / (L) Rear Trim - Grime - Small / Rear Seat - Grime - Small / (R) Front Trim - Grime - Medium / (R) Rear Trim - Grime - Small / Steering Wheel - Worn, Peel, Crack - Small</p> | <p><b>Remarks</b></p> <p>(L) Front Fender, Molding - Scratch - Small / (L) Front Door, Molding - Scratch &amp; Dent - Medium / (L) Rear Door, Molding - Scratch &amp; Dent - Large / Trunk Hood, Rear Gate - Dent - Small / Rear Bumper, Lamps, Panels - Scratch &amp; Dent - Medium / (R) Rear Fender, Molding - Scratch &amp; Dent - Small / (R) Rear Door, Molding - Scratch - Large / (R) Front Door, Molding - Scratch - Large / (R) Mirror - Scratch - Minimal / (R) Front Fender, Molding - Scratch - Small / Front Bumper, Grille, Lamps - Scratch - Medium / Bonnet, Headlight - Scratch - Minimal / (L) Rear Fender, Molding - Scratch - Minimal / Roof - Dent - Small</p> |
