## General Information

| Make | Toyota | Model | Vios |

## Body / Panel Condition

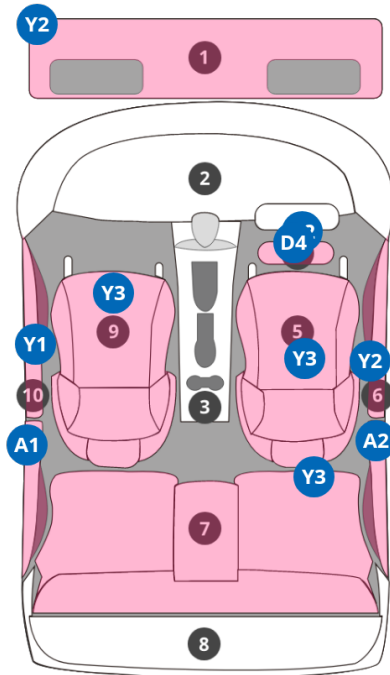
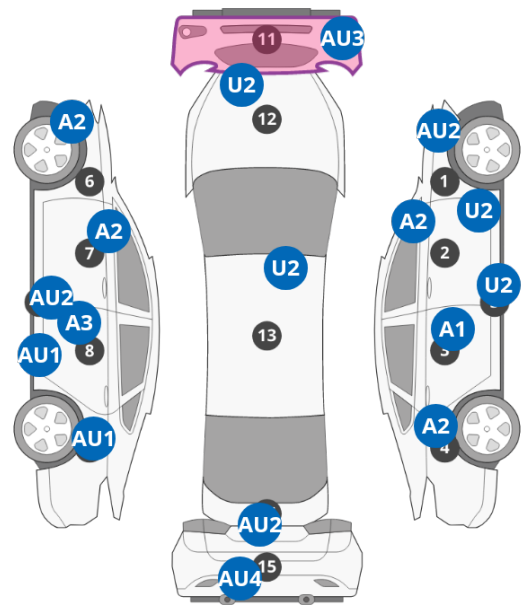
| Interior Evaluation : <b>C</b> | Exterior Evaluation : <b>E</b> |
| <b>Remarks</b><br>(R) Front Seat - Grime - Medium / (L) Front Seat - Grime - Medium / Rear Seat - Grime - Medium / (R) Rear Trim - Cut, Crack - Small / (R) Front Floor Mat - Worked - Small / (R) Front Trim - Grime - Small / (L) Rear Trim - Cut, Crack - Minimal / (L) Front Trim - Grime - Minimal / (L) Front Floor Mat - Worked - Large / Ceiling - Grime - Small | <b>Remarks</b><br>(R) Front Door - Repair Traces - Yes / (R) Front Fender, Molding - Scratch & Dent - Small / (R) Mirror - Scratch - Small / (R) Front Door, Molding - Dent - Small / (R) Rear Door, Molding - Scratch - Minimal / (R) Step, In-panel, Side Spoiler - Dent - Small / (R) Rear Fender, Molding - Scratch - Small / Rear Bumper, Lamps, Panels - Scratch & Dent - Large / Trunk Hood, Rear Gate - Scratch & Dent - Small / (L) Rear Fender, Molding - Scratch & Dent - Minimal / (L) Rear Door, Molding - Scratch - Medium / (L) Step, In-panel, Side Spoiler - Scratch & Dent - Minimal / (L) Mirror - Scratch - Small / (L) Front Door, Molding - Scratch & Dent - Small / (L) Front Fender, Molding - Scratch - Small / Front Bumper, Grille, Lamps - Repair mark - Yes / Front Bumper, Grille, Lamps - Scratch & Dent - Medium / Bonnet, Headlight - Dent - Small / Roof - Dent - Small |
