## General Information

| Make | Toyota | Model | Vios |
| Registration No. | DBA8198 | Chassis No. | PA1B18F36L4118030 |

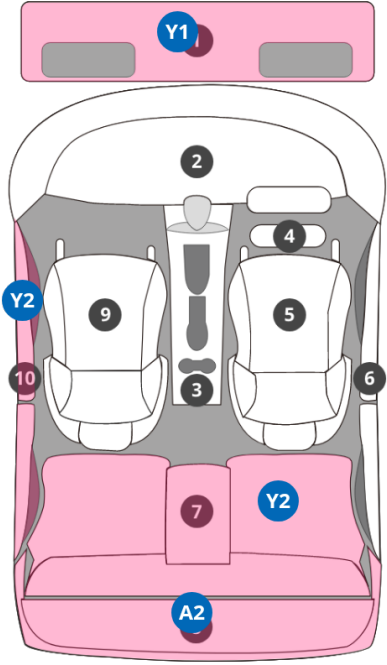
| Interior Evaluation : <span style="color: red;">A</span> | Exterior Evaluation : <span style="color: red;">C</span> |
|---|---|
| <b>Remarks</b><br>Rear Seat - Grime - Small / Trunk Room - Worn, Scratch, Cut, Crack - Small / Ceiling - Grime - Minimal / (L) Front Trim - Grime - Small | <b>Remarks</b><br>(R) Front Fender - Repair Traces - Yes / Bonnet - Repair Traces - Yes / (L) Front Fender - Repair Traces - Yes / Trunk Hood, Rear Gate - Repair Traces - Yes / (L) Rear Fender, Molding - Scratch & Dent - Medium / Rear Bumper, Lamps, Panels - Scratch - Small / (L) Rear Door, Molding - Dent - Small / (L) Front Door, Molding - Scratch - Small / (L) Front Fender, Molding - Scratch - Small / Bonnet, Headlight - Scratch & Dent - Small / (R) Front Fender, Molding - Scratch - Minimal / (R) Rear Door, Molding - Scratch - Small / (R) Rear Fender, Molding - Scratch - Minimal / Trunk Hood, Rear Gate - Crack, Gap - Medium / Roof - Dent - Small / Front Bumper, Grille, Lamps - Scratch & Dent - Large |
