## General Information

| Make | Toyota | Model | Vios |

## Body / Panel Condition

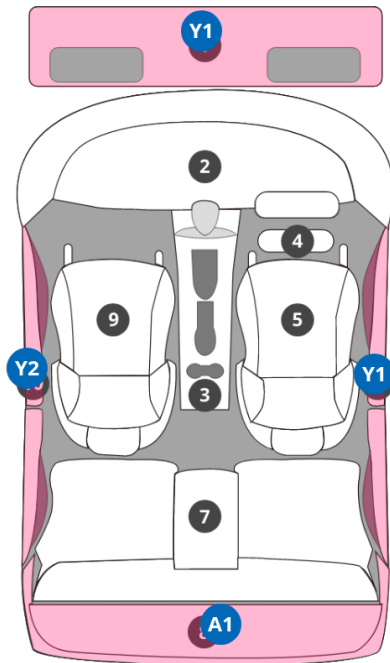
| Interior Evaluation : <b>A</b> | Exterior Evaluation : <b>C</b> |
| <b>Remarks</b><br>Ceiling - Grime - Minimal / (L) Front Trim - Grime - Small / (R) Front Trim - Grime - Minimal / Trunk Room - Worn, Scratch, Cut, Crack - Minimal | <b>Remarks</b><br>(R) Front Fender, Molding - Scratch - Minimal / (R) Mirror - Scratch - Minimal / (R) Front Door, Molding - Scratch - Small / (R) Step, In-panel, Side Spoiler - Scratch - Small / (R) Rear Door, Molding - Scratch - Minimal / (R) Rear Fender, Molding - Scratch - Small / Rear Bumper, Lamps, Panels - Scratch & Dent - Small / Trunk Hood, Rear Gate - Scratch - Minimal / (L) Rear Fender, Molding - Scratch - Minimal / (L) Rear Door, Molding - Scratch - Small / (L) Front Door, Molding - Scratch - Small / (L) Mirror - Scratch - Minimal / (L) Front Fender, Molding - Scratch - Minimal / Front Bumper, Grille, Lamps - Scratch - Small / Bonnet, Headlight - Scratch - Small / Roof - Scratch - Small |
