## General Information

| Make | Toyota | Model | Vios |

## Body / Panel Condition

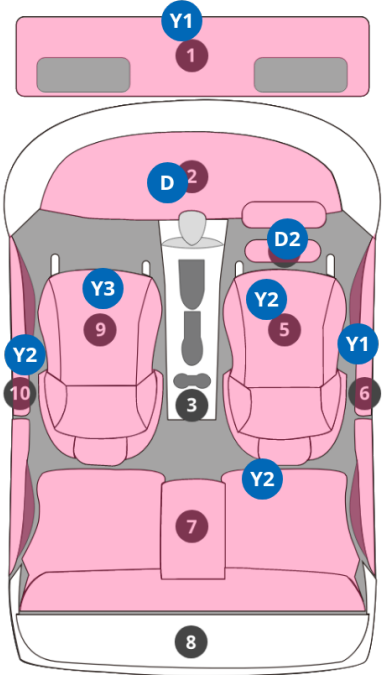
| <b>Interior Evaluation :</b> <span style="color: red; font-weight: bold;">B</span> | <b>Exterior Evaluation :</b> <span style="color: red; font-weight: bold;">C</span> |
| <b>Remarks</b><br>(L) Front Trim - Grime - Small / Dashboard - Traces of Adhesive Tape - Yes / Ceiling - Grime - Minimal / (R) Front Seat - Grime - Small / (L) Front Seat - Grime - Medium / (L) Front Floor Mat - Worked - Small / Rear Seat - Grime - Small / (R) Front Trim - Grime - Minimal | <b>Remarks</b><br>Trunk Hood, Rear Gate - Repair Traces - Yes / (R) Front Fender, Molding - Scratch - Minimal / (R) Mirror - Scratch - Small / (R) Front Door, Molding - Scratch - Small / (R) Rear Door, Molding - Scratch - Small / (R) Rear Fender, Molding - Scratch - Minimal / Rear Bumper, Lamps, Panels - Scratch - Medium / Trunk Hood, Rear Gate - Scratch - Minimal / (L) Rear Door, Molding - Scratch - Small / (L) Mirror - Scratch - Minimal / (L) Front Door, Molding - Scratch - Minimal / (L) Front Fender, Molding - Scratch - Minimal / Front Bumper, Grille, Lamps - Scratch & Dent - Large / Bonnet, Headlight - Dent - Medium |
