## General Information

| Make | Toyota | Model | Vios |
| YOM | 2024 | Mileage | 15,559 |
| Registration No. | DBN1684 | Chassis No. | PA1B18F33P4228877 |

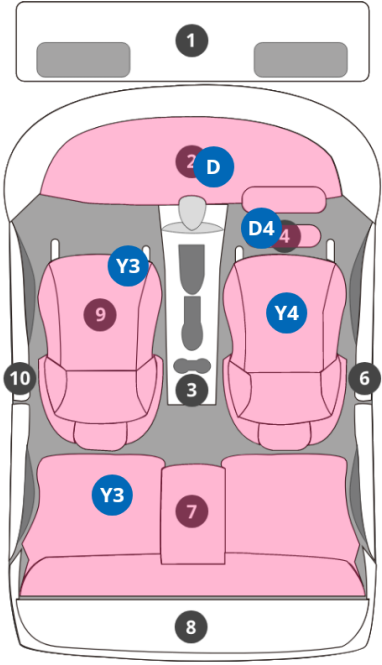
| Interior Evaluation : <span style="color: red;">C</span> | Exterior Evaluation : <span style="color: red;">D</span> |
|---|---|
| <b>Remarks</b><br>(R) Front Seat - Grime - Large / (L) Front Seat - Grime - Medium / (L) Front Floor Mat - Worked - Large / Rear Seat - Grime - Medium / Dashboard - Traces of Adhesive Tape - Yes | <b>Remarks</b><br>(R) Front Door - Repair Traces - Yes / Trunk Hood, Rear Gate - Repair Traces - Yes / (R) Rear Door - Repair Traces - Yes / (L) Rear Fender, Molding - Scratch & Dent - Small / (L) Front Door, Molding - Scratch - Small / (L) Rear Door, Molding - Dent - Small / Front Bumper, Grille, Lamps - Scratch & Dent - Large / Bonnet, Headlight - Crack, Gap - Medium / (R) Rear Door, Molding - Dent - Small / (R) Step, In-panel, Side Spoiler - Dent - Small / (R) Front Door, Molding - Scratch - Medium / Roof - Dent - Small / Rear Bumper, Lamps, Panels - Scratch & Dent - Small / Trunk Hood, Rear Gate - Modified - Medium |
