## General Information

| Make | Toyota | Model | Vios |
| YOM | 2024 | Mileage | 11,041 |
| Registration No. | DBN1098 | Chassis No. | PA1B18F34P4228791 |

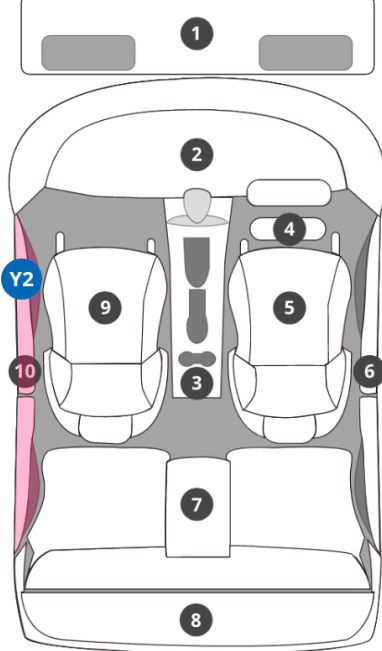
| <b>Interior Evaluation :</b> <span style="color: red; font-weight: bold;">A</span> | <b>Exterior Evaluation :</b> <span style="color: red; font-weight: bold;">C</span> |
| <b>Remarks</b><br>(L) Front Trim - Grime - Small | <b>Remarks</b><br>Rear Bumper, Lamps, Panels - Scratch & Dent - Medium / Trunk Hood, Rear Gate - Scratch - Minimal / (L) Rear Door, Molding - Scratch - Small / (L) Rear Fender, Molding - Scratch - Minimal / (L) Front Door, Molding - Scratch - Large / (L) Front Fender, Molding - Scratch - Minimal / Front Bumper, Grille, Lamps - Scratch - Minimal / (R) Mirror - Scratch - Small / (R) Front Fender, Molding - Scratch - Minimal / (R) Rear Door, Molding - Scratch - Minimal / (R) Front Door, Molding - Scratch - Minimal / Bonnet, Headlight - Scratch - Medium |

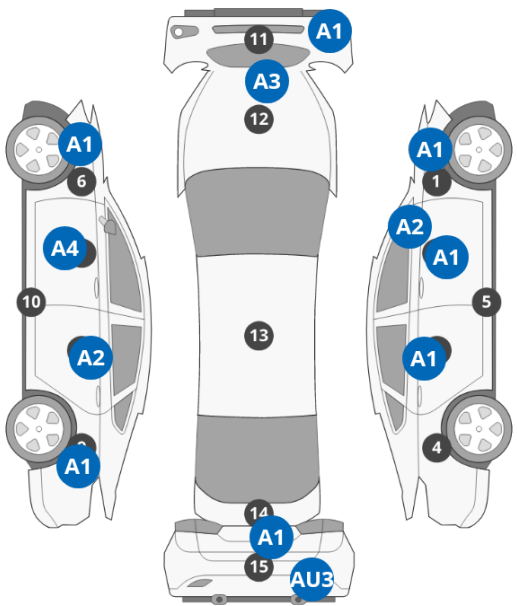
| with LTO plate/with spare tire/with warranty booklets/with jack and incomplete tools/No reverse camera/left and right fender faded color/bonnet faded color |
