## General Information

| Make | Toyota | Model | Vios |

## Body / Panel Condition

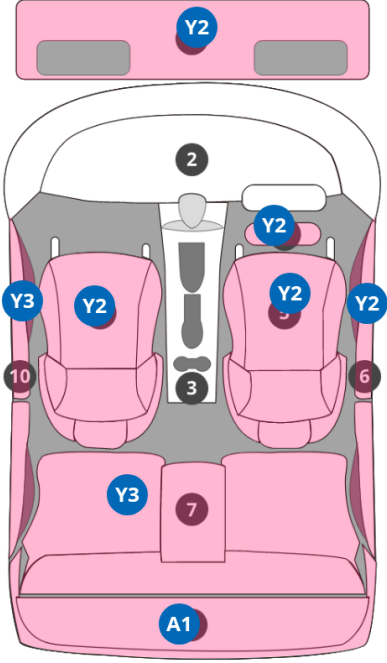
| Interior Evaluation : <span style="color: red;">C</span> | Exterior Evaluation : <span style="color: red;">B</span> |
| <b>Remarks</b><br>Rear Seat - Grime - Medium / (L) Front Seat - Grime - Small / (L) Front Floor Mat - Grime - Small / (L) Front Trim - Grime - Medium / (R) Front Trim - Grime - Small / (R) Front Seat - Grime - Small / Ceiling - Grime - Small / Trunk Room - Worn, Scratch, Cut, Crack - Minimal | <b>Remarks</b><br>(R) Rear Fender, Molding - Scratch - Minimal / Trunk Hood, Rear Gate - Scratch - Minimal / Rear Bumper, Lamps, Panels - Scratch - Small / (L) Rear Fender, Molding - Scratch - Minimal / (L) Rear Door, Molding - Scratch - Minimal / (L) Front Door, Molding - Scratch - Minimal / (L) Front Fender, Molding - Scratch - Minimal / Front Bumper, Grille, Lamps - Scratch - Small / Bonnet, Headlight - Scratch - Minimal / (R) Front Fender, Molding - Scratch - Small / (R) Front Door, Molding - Scratch - Small / (R) Rear Door, Molding - Scratch - Minimal |
