## General Information

| Make | Toyota | Model | Vios |
| YOM | 2023 | Mileage | 69,390 |
| Registration No. | NFC5345 | Chassis No. | PA1B18F34P4207911 |

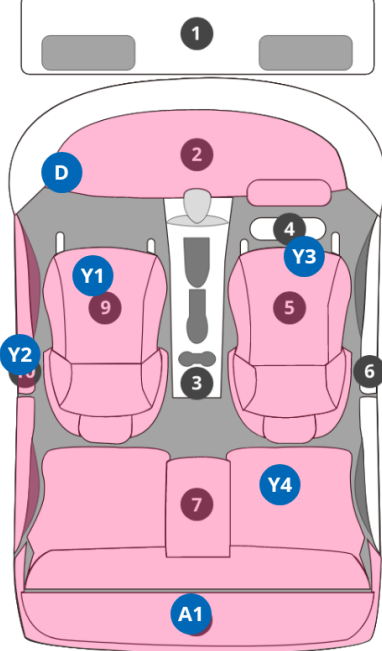
| Interior Evaluation : <span style="color: red;">C</span> | Exterior Evaluation : <span style="color: red;">C</span> |
|---|---|
| <p><b>Remarks</b></p> <p>(R) Front Seat - Grime - Medium / Rear Seat - Grime - Large / Trunk Room - Worn, Scratch, Cut, Crack - Minimal / (L) Front Trim - Grime - Small / (L) Front Seat - Grime - Minimal / Dashboard - Traces of Adhesive Tape - Yes</p> | <p><b>Remarks</b></p> <p>(R) Front Fender, Molding - Scratch - Minimal / (R) Mirror - Scratch - Minimal / (R) Front Door, Molding - Scratch - Small / (R) Rear Door, Molding - Scratch - Minimal / Roof - Dent - Small / (R) Rear Fender, Molding - Scratch - Small / Rear Bumper, Lamps, Panels - Scratch &amp; Dent - Medium / Trunk Hood, Rear Gate - Scratch - Small / (L) Rear Fender, Molding - Scratch - Small / (L) Rear Door, Molding - Scratch - Small / (L) Front Door, Molding - Scratch &amp; Dent - Small / (L) Step, In-panel, Side Spoiler - Scratch - Medium / (L) Mirror - Scratch - Minimal / (L) Front Fender, Molding - Scratch - Minimal / Front Bumper, Grille, Lamps - Scratch - Small / Bonnet, Headlight - Scratch &amp; Dent - Small</p> |
