## General Information

| Make | Subaru | Model | Outback |
| YOM | 2017 | Mileage | 120,953 |

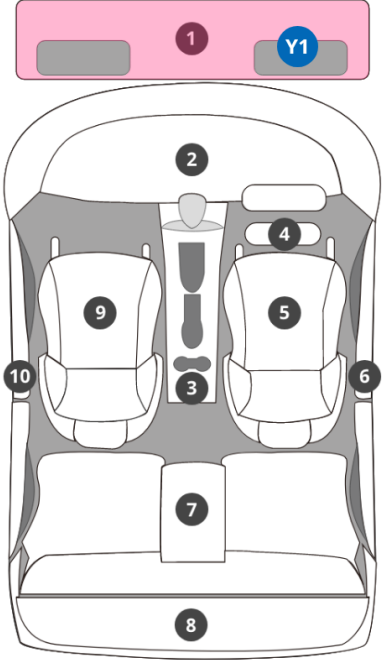
| <b>Interior Evaluation :</b> <span style="color: red; font-weight: bold;">A</span> | <b>Exterior Evaluation :</b> <span style="color: red; font-weight: bold;">C</span> |
| <b>Remarks</b><br>Ceiling - Grime - Minimal | <b>Remarks</b><br>(R) Front Fender, Molding - Dent - Medium / (R) Rear Fender, Molding - Scratch - Minimal / Rear Bumper, Lamps, Panels - Scratch & Dent - Small / Trunk Hood, Rear Gate - Scratch - Minimal / (L) Rear Fender, Molding - Scratch - Minimal / (L) Rear Door, Molding - Scratch - Minimal / (L) Front Door, Molding - Scratch & Dent - Minimal / (L) Mirror - Scratch - Minimal / Front Bumper, Grille, Lamps - Scratch - Medium / Bonnet, Headlight - Scratch - Minimal / Roof - Scratch - Minimal / (R) Rear Door, Molding - Scratch & Dent - Medium / (R) Front Door, Molding - Scratch & Dent - Medium |

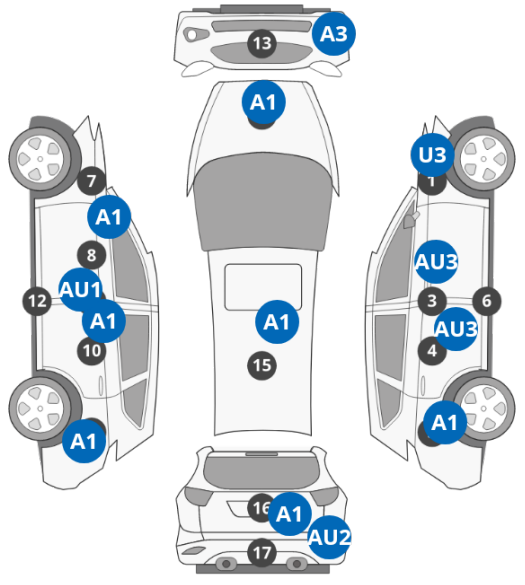
| with LTO plate, no warranty booklet, with jack and tools, with spare tire/shallow dent on right front and rear Door |
