## General Information

| Make | Toyota | Model | Vios |

## Body / Panel Condition

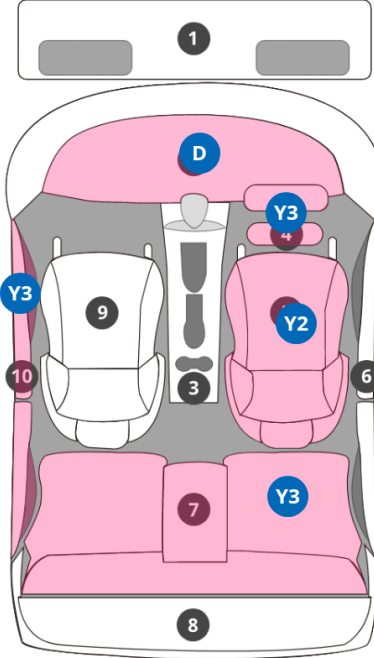
| Interior Evaluation : B | Exterior Evaluation : C |
| <b>Remarks</b><br>(L) Front Floor Mat - Grime - Medium / (L) Front Trim - Grime - Medium / Dashboard - Traces of Adhesive Tape - Yes / (R) Front Seat - Grime - Small / Rear Seat - Grime - Medium | <b>Remarks</b><br>Member (Bolted) - Rust, Corrosion - Yes / (L) Rear Fender, Molding - Scratch & Dent - Small / (L) Rear Door, Molding - Scratch - Medium / (L) Mirror - Scratch - Minimal / (L) Front Door, Molding - Scratch - Minimal / Rear Bumper, Lamps, Panels - Scratch & Dent - Large / Trunk Hood, Rear Gate - Scratch - Minimal / (R) Rear Fender, Molding - Scratch - Small / (R) Rear Door, Molding - Scratch - Minimal / (R) Front Door, Molding - Scratch - Minimal / Front Bumper, Grille, Lamps - Scratch - Small / (R) Step, In-panel, Side Spoiler - Dent - Minimal |
