## General Information

| Make | Toyota | Model | Vios |
| Registration No. | NHI7417 | Chassis No. | PA1B18F34P4210534 |

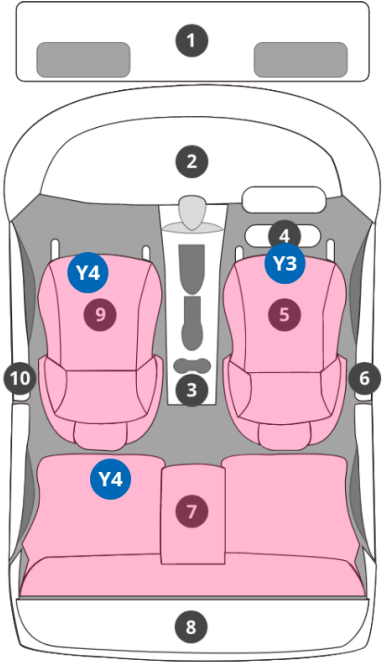
| Interior Evaluation : <span style="color: red;">C</span> | Exterior Evaluation : <span style="color: red;">E</span> |
|---|---|
| <b>Remarks</b><br>(L) Front Seat - Grime - Large / (R) Front Seat - Grime - Medium / Rear Seat - Grime - Large | <b>Remarks</b><br>(R) Rear Door, Molding - Scratch & Dent - Large / (R) Rear Fender, Molding - Scratch & Dent - Small / (R) Front Door, Molding - Scratch & Dent - Medium / (R) Step, In-panel, Side Spoiler - Scratch & Dent - Medium / (R) Front Fender, Molding - Scratch - Medium / Front Bumper, Grille, Lamps - Scratch & Dent - Large / Bonnet, Headlight - Dent - Small / (L) Front Door, Molding - Scratch - Medium / (L) Rear Door, Molding - Scratch - Minimal / Rear Bumper, Lamps, Panels - Scratch - Large / Trunk Hood, Rear Gate - Dent - Small / (L) Rear Fender, Molding - Scratch - Small |
