## General Information

| Make | Toyota | Model | Vios |
| YOM | 2023 | Mileage | 21,265 |

## Body / Panel Condition

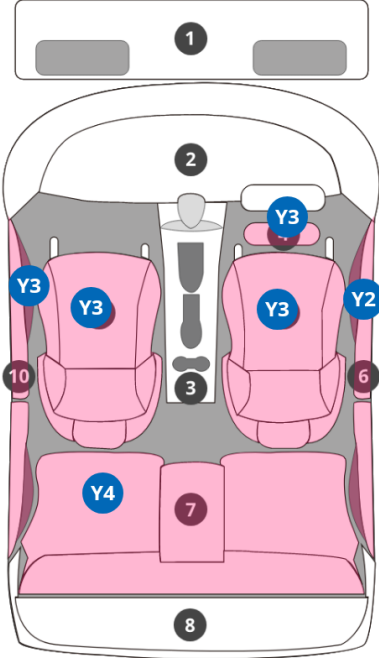
| Interior Evaluation : <span style="color: red; font-weight: bold;">C</span> | | Exterior Evaluation : <span style="color: red; font-weight: bold;">D</span> | |
|---|--|---|--|
| <b>Remarks</b><br>(L) Front Floor Mat - Grime - Medium / (L) Front Seat - Grime - Medium / Rear Seat - Grime - Large / (R) Front Seat - Grime - Medium / (R) Front Trim - Grime - Small / (L) Front Trim - Grime - Medium | | <b>Remarks</b><br>Rear Bumper, Lamps, Panels - Scratch - Medium / Trunk Hood, Rear Gate - Scratch - Small / (R) Rear Fender, Molding - Scratch - Minimal / (R) Rear Door, Molding - Scratch - Small / (R) Front Door, Molding - Scratch - Small / (R) Front Fender, Molding - Dent - Medium / Front Bumper, Grille, Lamps - Scratch - Medium / Bonnet, Headlight - Scratch - Small / (L) Mirror - Scratch - Minimal / (L) Front Door, Molding - Scratch - Medium / (L) Step, In-panel, Side Spoiler - Scratch - Medium / (L) Rear Fender, Molding - Dent - Minimal / (L) Rear Door, Molding - Scratch - Minimal / (L) Front Fender, Molding - Scratch - Minimal | |
