## General Information

| Make | Toyota | Model | Vios |
| Registration No. | VAB8914 | Chassis No. | PA1B18F30P4234250 |

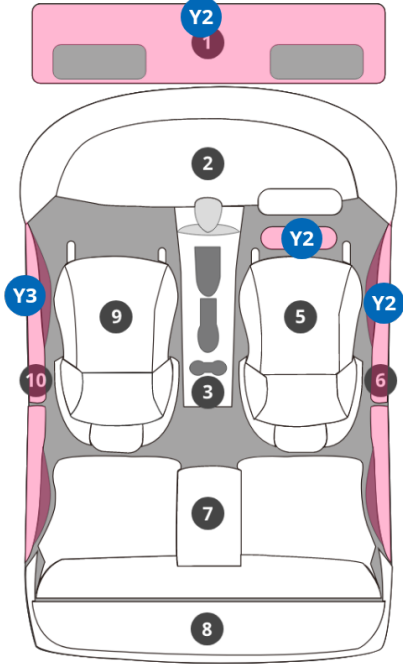
| Interior Evaluation : <b>B</b> | Exterior Evaluation : <b>B</b> |
|---|---|
| <b>Remarks</b><br>(R) Front Trim - Grime - Small / (L) Front Trim - Grime - Medium / (L) Front Floor Mat - Grime - Small / Ceiling - Grime - Small | <b>Remarks</b><br>(R) Rear Fender - Repair Traces - Yes / Rear Bumper, Lamps, Panels - Scratch - Small / (L) Rear Fender, Molding - Scratch & Dent - Minimal / (L) Rear Door, Molding - Scratch - Medium / (L) Front Door, Molding - Scratch - Small / (L) Front Fender, Molding - Scratch - Minimal / Front Bumper, Grille, Lamps - Scratch - Medium / (R) Mirror - Scratch - Minimal / (R) Front Door, Molding - Scratch - Minimal / (R) Rear Door, Molding - Scratch - Minimal / (R) Rear Fender, Molding - Scratch - Minimal / Roof - Scratch & Dent - Small |
