## General Information

| Make | Toyota | Model | Vios |

## Body / Panel Condition

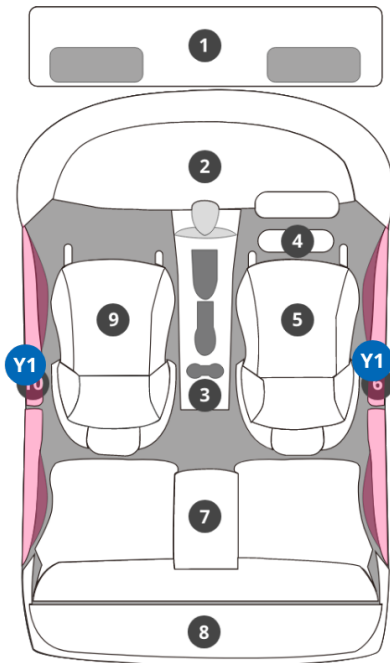
| <b>Interior Evaluation :</b> <span style="color: red; font-weight: bold;">A</span> | <b>Exterior Evaluation :</b> <span style="color: red; font-weight: bold;">C</span> |
| <b>Remarks</b><br>(L) Front Trim - Grime - Minimal / (R) Front Trim - Grime - Minimal | <b>Remarks</b><br>(R) Front Fender, Molding - Dent - Small / (R) Front Door, Molding - Scratch - Minimal / (R) Rear Door, Molding - Scratch - Minimal / (R) Rear Fender, Molding - Scratch - Minimal / Rear Bumper, Lamps, Panels - Scratch - Minimal / Trunk Hood, Rear Gate - Scratch - Small / (L) Rear Fender, Molding - Scratch - Minimal / (L) Rear Door, Molding - Scratch - Minimal / (L) Front Door, Molding - Scratch - Minimal / (L) Front Fender, Molding - Scratch - Minimal / Front Bumper, Grille, Lamps - Scratch & Dent - Large / Bonnet, Headlight - Scratch - Small |
