## General Information

| Make | Toyota | Model | Vios |

## Body / Panel Condition

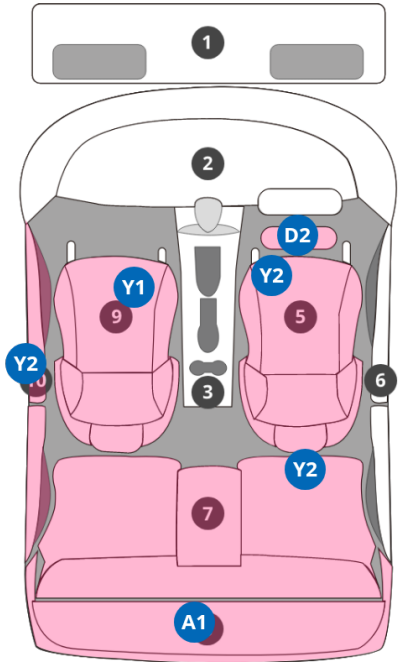
| Interior Evaluation : <b>B</b> | Exterior Evaluation : <b>C</b> |
|---|---|
| <p><b>Remarks</b></p> <p>(R) Front Seat - Grime - Small / Rear Seat - Grime - Small / Trunk Room - Worn, Scratch, Cut, Crack - Minimal / (L) Front Seat - Grime - Minimal / (L) Front Trim - Grime - Small / (L) Front Floor Mat - Worked - Small</p> | <p><b>Remarks</b></p> <p>(R) Front Fender - Repair Traces - Yes / (R) Front Fender, Molding - Repair mark - Yes / (R) Front Fender, Molding - Scratch &amp; Dent - Medium / (R) Mirror - Scratch - Minimal / (R) Front Door, Molding - Scratch - Minimal / (R) Rear Door, Molding - Scratch - Minimal / (R) Rear Fender, Molding - Scratch - Small / Rear Bumper, Lamps, Panels - Scratch - Minimal / Trunk Hood, Rear Gate - Scratch - Minimal / (L) Rear Fender, Molding - Scratch - Minimal / (L) Rear Door, Molding - Scratch - Minimal / (L) Front Door, Molding - Scratch - Minimal / Roof - Scratch - Minimal / (L) Mirror - Scratch - Minimal / (L) Front Fender, Molding - Scratch - Minimal / Front Bumper, Grille, Lamps - Scratch - Medium / Bonnet, Headlight - Scratch &amp; Dent - Small</p> |
