## General Information

| Make | Toyota | Model | Vios |
| Registration No. | NHM4612 | Chassis No. | PA1B18F35P4238309 |

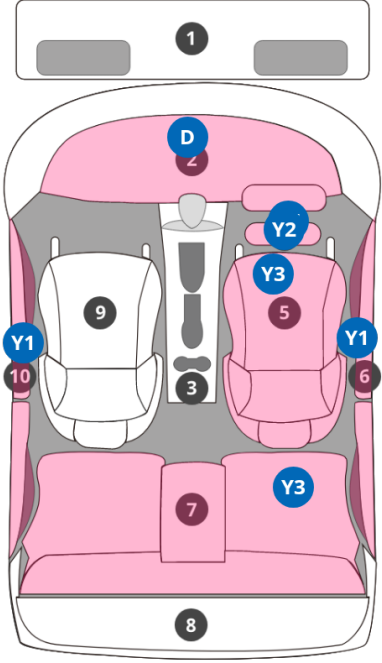
| Interior Evaluation : <span style="color: red;">C</span> | Exterior Evaluation : <span style="color: red;">C</span> |
|---|---|
| <p><b>Remarks</b><br/>(R) Front Seat - Grime - Medium / Rear Seat - Grime - Medium / (R) Front Trim - Grime - Minimal / (L) Front Floor Mat - Worked - Large / (L) Front Floor Mat - Grime - Small / (L) Front Trim - Grime - Minimal / Dashboard - Traces of Adhesive Tape - Yes</p> | <p><b>Remarks</b><br/>(R) Mirror - Scratch - Minimal / (R) Front Door, Molding - Scratch - Small / (R) Rear Door, Molding - Scratch - Small / Rear Bumper, Lamps, Panels - Scratch &amp; Dent - Large / Trunk Hood, Rear Gate - Scratch &amp; Dent - Small / (L) Mirror - Scratch - Minimal / (L) Front Fender, Molding - Scratch - Minimal / Front Bumper, Grille, Lamps - Scratch - Medium / (R) Rear Fender, Molding - Scratch - Small</p> |

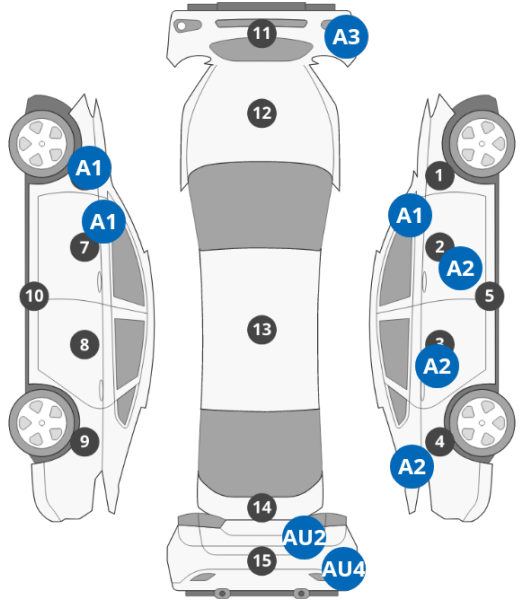
| Inspector Notes |
|---|
| no warranty booklet, with jack, no tools, with spare tire, with LTO plate, scratches on tail light |
