## General Information

| Make | Toyota | Model | Vios |
| Registration No. | NEY8825 | Chassis No. | PA1B18F39R4258811 |

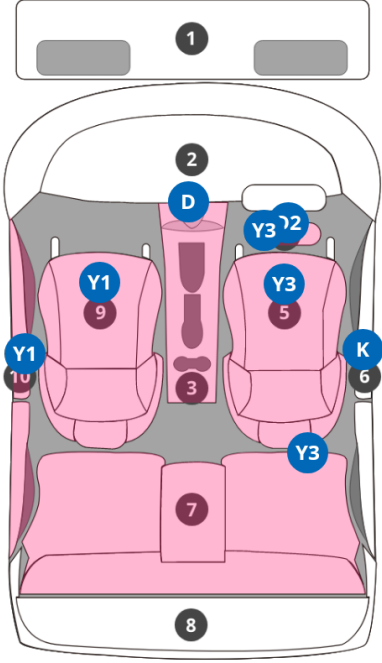
| Interior Evaluation : <b>B</b> | Exterior Evaluation : <b>C</b> |
| <p><b>Remarks</b><br/>(R) Front Seat - Grime - Medium / (L) Front Seat - Grime - Minimal / (L) Front Floor Mat - Worked - Small / Rear Seat - Grime - Medium / (R) Front Floor Mat - Grime - Medium / Overall Interior - Animal Hair - Yes / (L) Front Trim - Grime - Minimal / Console, Switchs, Vents - Traces of Adhesive Tape - Yes</p> | <p><b>Remarks</b><br/>(R) Front Fender, Molding - Scratch - Small / (R) Front Door, Molding - Scratch - Minimal / (R) Rear Door, Molding - Scratch - Minimal / (R) Rear Fender, Molding - Scratch - Minimal / Rear Bumper, Lamps, Panels - Scratch &amp; Dent - Medium / (L) Mirror - Scratch - Small / Front Bumper, Grille, Lamps - Scratch &amp; Dent - Large / Bonnet, Headlight - Dent - Medium</p> |

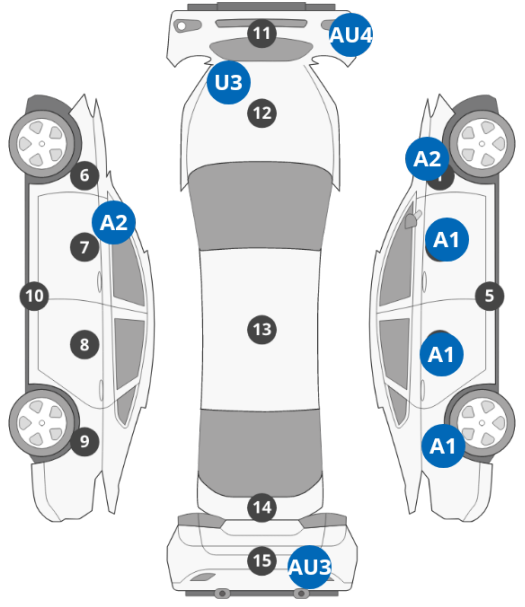
| Inspector Notes |
|---|
| no warranty booklet, with jack and tools, with spare tire, with LTO plate, scratches on tail light |
