## General Information

| Make | Toyota | Model | Vios |
| Registration No. | DBR4194 | Chassis No. | PA1B18F36R4276103 |

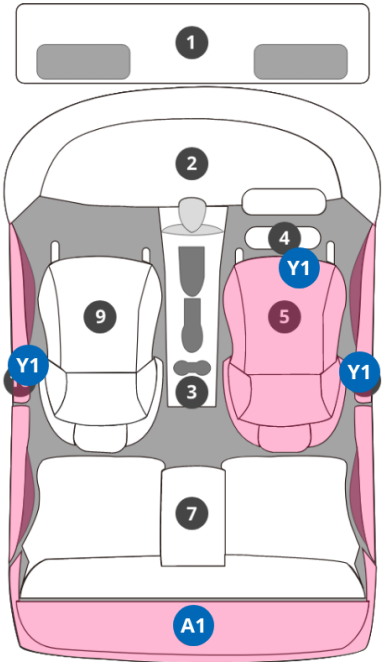
| <b>Interior Evaluation :</b> <span style="color: red; font-weight: bold;">A</span> | <b>Exterior Evaluation :</b> <span style="color: red; font-weight: bold;">B</span> |
| <b>Remarks</b><br>(R) Front Trim - Grime - Minimal / (R) Front Seat - Grime - Minimal / (L) Front Trim - Grime - Minimal / Trunk Room - Worn, Scratch, Cut, Crack - Minimal | <b>Remarks</b><br>(R) Front Fender, Molding - Scratch - Minimal / (R) Front Door, Molding - Scratch - Minimal / (R) Rear Door, Molding - Scratch - Minimal / (R) Rear Fender, Molding - Scratch - Minimal / Rear Bumper, Lamps, Panels - Scratch - Medium / Trunk Hood, Rear Gate - Scratch - Minimal / (L) Rear Fender, Molding - Scratch - Minimal / (L) Rear Door, Molding - Scratch - Minimal / (L) Front Door, Molding - Scratch - Minimal / (L) Front Fender, Molding - Scratch - Minimal / Front Bumper, Grille, Lamps - Scratch - Minimal / Bonnet, Headlight - Scratch - Minimal |
