## General Information

| Make | Toyota | Model | Avanza |
| YOM | 2024 | Mileage | 2,155 |

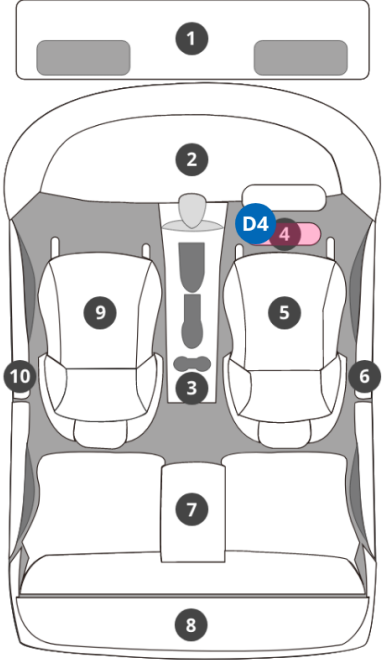
| Interior Evaluation : <span style="color: red;">C</span> | Exterior Evaluation : <span style="color: red;">C</span> |
| <p><b>Remarks</b><br/>(L) Front Floor Mat - Worked - Large</p> | <p><b>Remarks</b><br/>Rear Bumper, Lamps, Panels - Dent - Large / (R) Rear Fender, Molding - Dent - Medium / Front Bumper, Grille, Lamps - Scratch &amp; Dent - Medium / (L) Rear Fender, Molding - Dent - Small / (R) Rear Door, Molding - Scratch - Minimal / (R) Front Door, Molding - Scratch - Minimal / (L) Front Door, Molding - Scratch - Minimal / (L) Rear Door, Molding - Scratch - Minimal</p> |
