## General Information

| Make | Toyota | Model | Vios |

## Body / Panel Condition

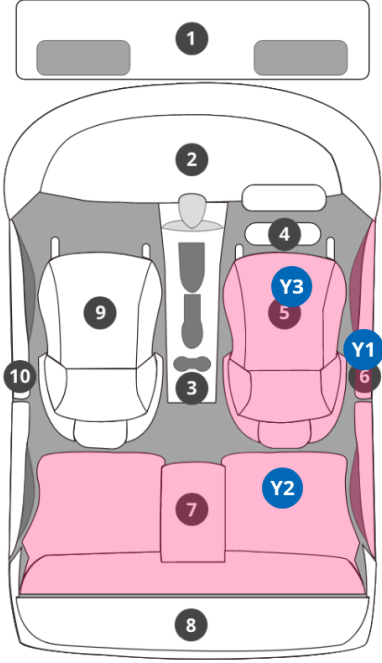
| Interior Evaluation : <b>B</b> | Exterior Evaluation : <b>D</b> |
| <p><b>Remarks</b><br/>Rear Seat - Grime - Small / (R) Front Seat - Grime - Medium / (R) Front Trim - Grime - Minimal</p> | <p><b>Remarks</b><br/>(R) Front Fender, Molding - Repair mark - Yes / (R) Front Fender, Molding - Scratch - Medium / (R) Step, In-panel, Side Spoiler - Scratch &amp; Dent - Large / (R) Front Door, Molding - Scratch - Medium / (R) Rear Door, Molding - Scratch - Medium / (R) Rear Door, Molding - Repair mark - Yes / (R) Rear Fender, Molding - Scratch - Small / Trunk Hood, Rear Gate - Scratch - Small / Rear Bumper, Lamps, Panels - Scratch - Minimal / (L) Rear Door, Molding - Scratch - Minimal / Front Bumper, Grille, Lamps - Scratch - Medium / Bonnet, Headlight - Scratch - Small / Roof - Scratch - Small</p> |
