## General Information

| Make | Toyota | Model | Vios |

## Body / Panel Condition

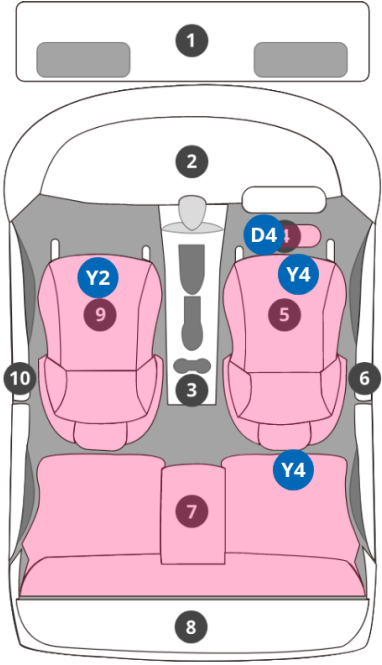
| Interior Evaluation : <span style="color: red; font-weight: bold;">C</span> | Exterior Evaluation : <span style="color: red; font-weight: bold;">C</span> |
|---|---|
| <p><b>Remarks</b></p> <p>Rear Seat - Grime - Large / (L) Front Floor Mat - Worked - Large / (L) Front Seat - Grime - Small / (R) Front Seat - Grime - Large</p> | <p><b>Remarks</b></p> <p>Rear Bumper, Lamps, Panels - Scratch &amp; Dent - Medium / (R) Rear Fender, Molding - Scratch &amp; Dent - Medium / Trunk Hood, Rear Gate - Crack, Gap - Medium / (R) Front Door, Molding - Scratch - Small / Front Bumper, Grille, Lamps - Scratch - Large / (L) Mirror - Scratch - Small / (L) Rear Door, Molding - Scratch - Small / (L) Rear Fender, Molding - Scratch - Small / (R) Mirror - Scratch - Small / (R) Rear Door, Molding - Scratch - Small</p> |
