## General Information

| Make | Toyota | Model | Vios |
| YOM | 2024 | Mileage | 27,632 |
| Registration No. | BAG2731 | Chassis No. | PA1B18F3XR4250779 |

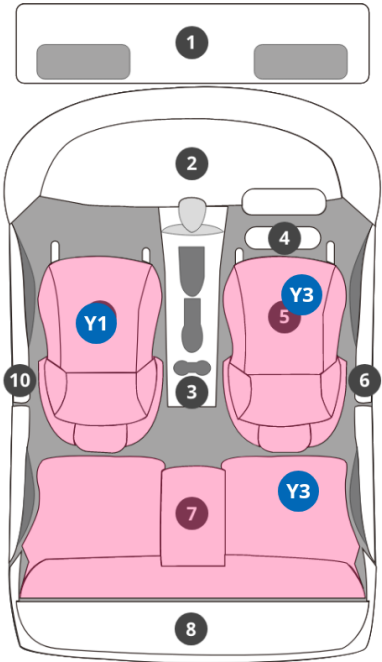
| <b>Interior Evaluation :</b> <b>B</b> | <b>Exterior Evaluation :</b> <b>B</b> |
| <b>Remarks</b><br>(R) Front Seat - Grime - Medium / Rear Seat - Grime - Medium / (L) Front Seat - Grime - Minimal | <b>Remarks</b><br>Bonnet - Repair Traces - Yes / Bonnet, Headlight - Repair mark - Yes / (R) Front Fender, Molding - Scratch - Minimal / (R) Front Door, Molding - Scratch & Dent - Small / (R) Mirror - Scratch - Minimal / Rear Bumper, Lamps, Panels - Scratch & Dent - Medium / Trunk Hood, Rear Gate - Scratch & Dent - Medium / (L) Rear Door, Molding - Scratch & Dent - Minimal / (L) Front Fender, Molding - Dent - Small / (L) Mirror - Scratch - Minimal / Front Bumper, Grille, Lamps - Scratch - Minimal |
