## General Information

| Make | Toyota | Model | Vios |
| YOM | 2024 | Mileage | 4,073 |
| Registration No. | DBP2133 | Chassis No. | PA1B18F3XR4259269 |

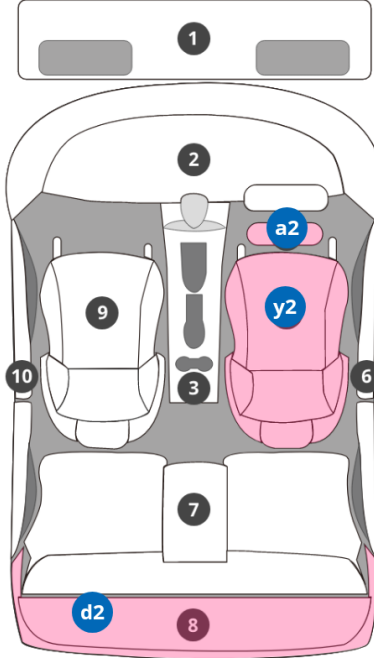
| Interior Evaluation : <span style="color: red; font-weight: bold;">A</span> | | Exterior Evaluation : <span style="color: red; font-weight: bold;">B</span> | |
|---|--|---|--|
| <p><b>Remarks</b></p> <p>Trunk Room - Loose, Deformed, Grime - Small / (R)<br/> Front Seat - Grime - Small / (L) Front Floor Lag - Cut, Crack - Small</p> | | <p><b>Remarks</b></p> <p>(R) Front Fender, Molding - Scratch - Medium / Front Bumper, Grille, Lamps - Scratch - Small / (L) Front Door, Molding - Scratch - Minimal / (L) Step, In-panel, Side Spoiler - Scratch - Small / (L) Rear Door, Molding - Scratch - Small / (L) Rear Fender, Molding - Scratch &amp; Dent - Medium / Rear Bumper, Lamps, Panels - Scratch - Small / Bonnet, Headlight - Scratch - Minimal / (R) Rear Fender, Molding - Scratch - Minimal</p> | |

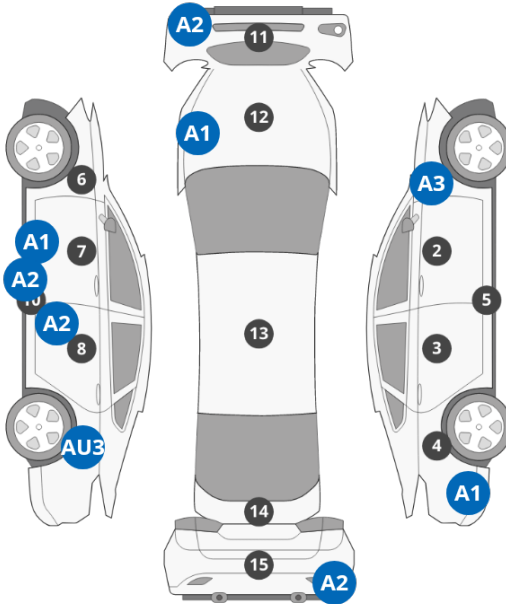
more light scratches around the exterior
