## General Information

| Make | Ford | Model | Ranger |
| YOM | 2013 | Mileage | 160,624 |
| Registration No. | BOY06 | Chassis No. | MNCLMFF80CW150700 |

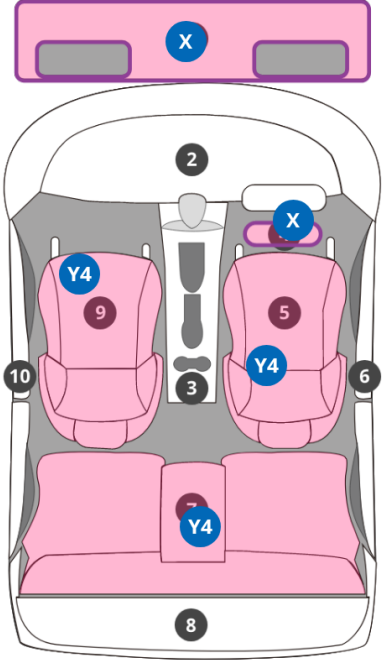
| Interior Evaluation : <b>C</b> | Exterior Evaluation : <b>E</b> |
| <b>Remarks</b><br>(L) Front Seat - Grime - Large / (R) Front Seat - Grime - Large / Rear Seat - Grime - Large / Mat Other - Missing - Yes / Sunvisor, Sunglass Holder - Missing - Yes | <b>Remarks</b><br>(R) Front Door - Repair Traces - Yes / (R) Rear Door - Repair Traces - Yes / (L) Side Gate - Scratch - Large / (L) Front Door, Molding - Scratch & Dent - Medium / Front Bumper, Grille, Lamps - Scratch & Dent - Large / Bonnet, Headlight - Dent - Small / (R) Front Fender, Molding - Scratch & Dent - Medium / (R) Front Door, Molding - Repair mark - Yes / (R) Front Door, Molding - Scratch - Medium / (R) Rear Door, Molding - Repair mark - Yes / (R) Rear Door, Molding - Scratch - Small / (R) Side Gate - Scratch & Dent - Large / Rear Bumper, Lamps, Panels - Crack, Gap - Large / Roof - Scratch & Dent - Small |
