## General Information

| Make | Toyota | Model | Wigo |
| YOM | 2022 | Mileage | 82,252 |
| Registration No. | NFD2379 | Chassis No. | MHKA4DF5FMJ063595 |

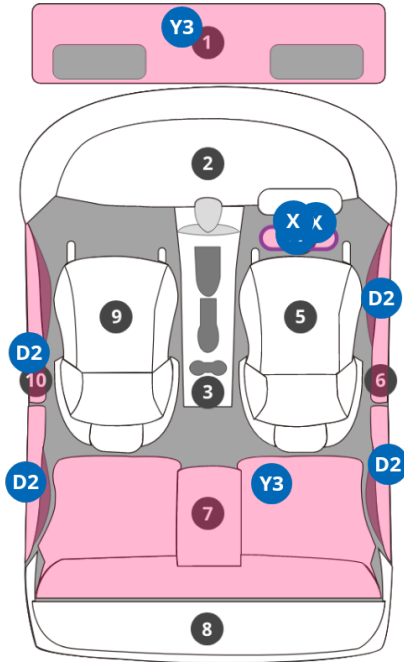
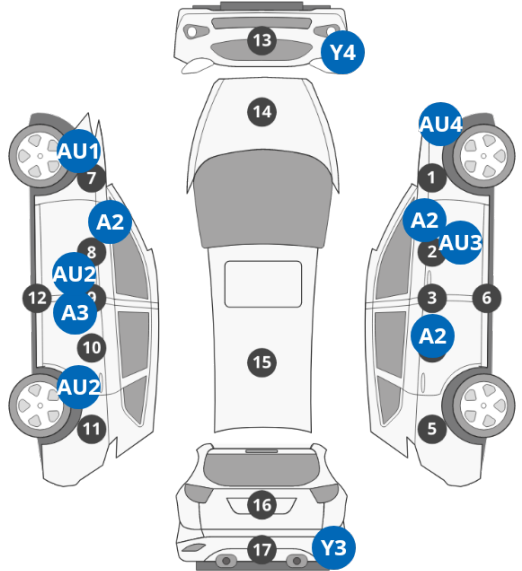
| Interior Evaluation : <b>C</b> | Exterior Evaluation : <b>D</b> |
|---|---|
| <p><b>a</b> : Cut, Fray <b>d</b> : Loose, Deformed <b>k</b> : Animal Hair <b>s</b> : Smell <b>t</b> : Cigarette Burns <b>x</b> : Defective <b>y</b> : Stain</p> | <p><b>A</b> : Scratch <b>AU</b> : Scratch &amp; Dent <b>B</b> : Modified <b>C</b> : Corrosion <b>G</b> : Stone chip <b>P</b> : Faded <b>S</b> : Rust <b>SC</b> : Rust &amp; Corrosion <b>U</b> : Dent <b>X</b> : Defective <b>Y</b> : Crack, Gap</p> |
| <p><b>Remarks</b></p> <p>Overall Interior - Worn as per age - Yes / (R) Front Floor Mat - Missing - Yes / (L) Front Floor Mat - Missing - Yes / Mat Other - Missing - Yes / Rear Seat - Grime - Medium / (R) Front Trim - Worked - Small / (L) Front Trim - Worked - Small / (L) Rear Trim - Worked - Small / (R) Rear Trim - Worked - Small / Ceiling - Grime - Medium</p> | <p><b>Remarks</b></p> <p>(R) Front Fender, Molding - Scratch &amp; Dent - Large / (R) Front Door, Molding - Scratch &amp; Dent - Medium / (R) Rear Door, Molding - Scratch - Small / Rear Bumper, Lamps, Panels - Crack, Gap - Medium / (L) Rear Fender, Molding - Scratch &amp; Dent - Small / (L) Rear Door, Molding - Scratch - Medium / (L) Front Door, Molding - Scratch &amp; Dent - Small / (L) Front Fender, Molding - Scratch &amp; Dent - Minimal / Front Bumper, Grille, Lamps - Crack, Gap - Large / (R) Mirror - Scratch - Small / (L) Mirror - Scratch - Small</p> |
