## General Information

| Make | Toyota | Model | Vios |
| YOM | 2023 | Mileage | 22,203 |
| Registration No. | CBI4275 | Chassis No. | PA1B18F36P4213791 |

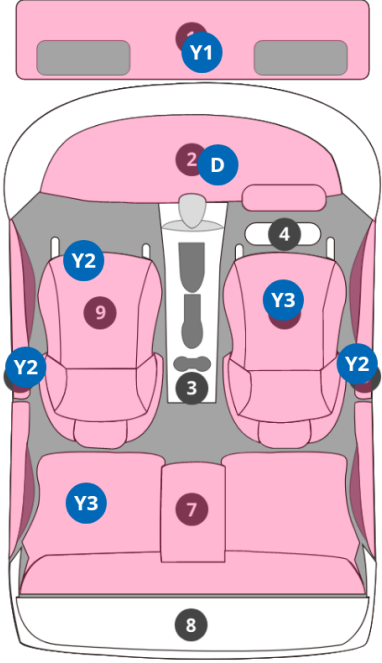
| Interior Evaluation : <b>B</b> | Exterior Evaluation : <b>E</b> |
|---|---|
| <p><b>Remarks</b></p> <p>(R) Front Seat - Grime - Medium / Rear Seat - Grime - Medium / (L) Front Seat - Grime - Small / (L) Front Trim - Grime - Small / (R) Front Trim - Grime - Small / Ceiling - Grime - Minimal / Dashboard - Traces of Adhesive Tape - Yes</p> | <p><b>Remarks</b></p> <p>(R) Step - Repair Traces - Yes / (R) Rear Fender - Repair Traces - Yes / (R) Rear Door - Repair Traces - Yes / (R) Rear Fender, Molding - Scratch &amp; Dent - Large / (R) Front Fender, Molding - Scratch &amp; Dent - Large / (R) Mirror - Scratch - Small / (R) Front Door, Molding - Scratch &amp; Dent - Large / (R) Rear Door, Molding - Scratch - Large / Rear Bumper, Lamps, Panels - Scratch &amp; Dent - Large / Trunk Hood, Rear Gate - Scratch - Small / (L) Rear Fender, Molding - Scratch - Small / (L) Mirror - Scratch - Minimal / (L) Rear Door, Molding - Scratch - Small / (L) Front Door, Molding - Scratch - Small / (R) Step, In-panel, Side Spoiler - Scratch - Small / Member (Bolted) - Dent - Yes / Front Bumper, Grille, Lamps - Scratch &amp; Dent - Large</p> |
