## General Information

| Make | Toyota | Model | Vios |
| YOM | 2023 | Mileage | 93,362 |
| Registration No. | NIJ1806 | Chassis No. | PA1B18F31P4204030 |

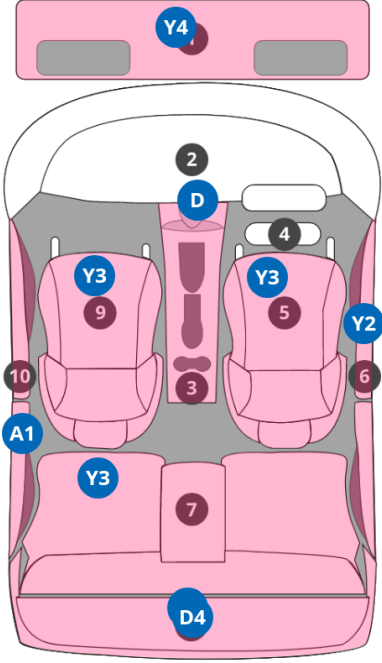
| Interior Evaluation : <span style="color: red;">C</span> | Exterior Evaluation : <span style="color: red;">E</span> |
| <p><b>a</b> : Cut, Fray <b>d</b> : Loose, Deformed <b>k</b> : Animal Hair <b>s</b> : Smell <b>t</b> : Cigarette Burns <b>x</b> : Defective <b>y</b> : Stain</p> | <p><b>A</b> : Scratch <b>AU</b> : Scratch &amp; Dent <b>B</b> : Modified <b>C</b> : Corrosion <b>G</b> : Stone chip <b>P</b> : Faded <b>S</b> : Rust <b>SC</b> : Rust &amp; Corrosion <b>U</b> : Dent <b>X</b> : Defective <b>Y</b> : Crack, Gap</p> |
| <p><b>Remarks</b></p> <p>(R) Front Seat - Grime - Medium / (L) Front Seat - Grime - Medium / Rear Seat - Grime - Medium / (R) Front Trim - Grime - Small / (L) Rear Trim - Cut, Crack - Minimal / Overall Interior - Worn as per age - Yes / Ceiling - Grime - Large / Console, Switches, Vents - Traces of Adhesive Tape - Yes / Overall Interior - Smell - Yes / Trunk Room - Loose, Deformed - Large</p> | <p><b>Remarks</b></p> <p>(R) Front Fender, Molding - Scratch - Small / (R) Front Door, Molding - Scratch &amp; Dent - Large / (R) Rear Door, Molding - Scratch &amp; Dent - Large / (R) Mirror - Scratch - Minimal / (R) Rear Fender, Molding - Scratch &amp; Dent - Medium / Trunk Hood, Rear Gate - Dent - Minimal / Rear Bumper, Lamps, Panels - Scratch &amp; Dent - Medium / (L) Front Door, Molding - Rust, Corrosion - Medium / (L) Rear Fender, Molding - Scratch - Small / (L) Step, In-panel, Side Spoiler - Scratch &amp; Dent - Medium / (L) Rear Door, Molding - Scratch - Minimal / (L) Mirror - Scratch - Small / Member (Bolted) - Dent - Yes / Front Bumper, Grille, Lamps - Scratch &amp; Dent - Medium / Bonnet, Headlight - Scratch &amp; Dent - Small</p> |

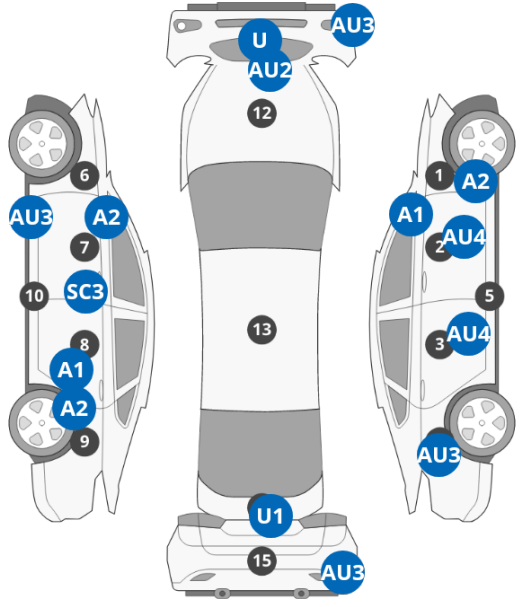
| Inspector Notes |
|---|
| no warranty booklet, with jack, no tools, with spare tire, with LTO plate, cracked tail light, plate light issue |
