## General Information

| Make | Toyota | Model | Vios |

## Body / Panel Condition

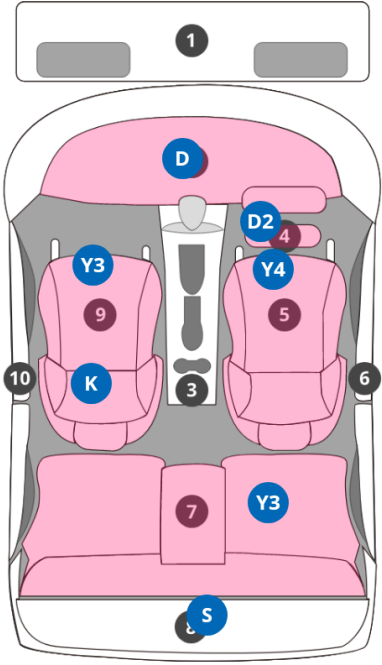
| Interior Evaluation : <span style="color: red;">C</span> | Exterior Evaluation : <span style="color: red;">C</span> |
| <b>Remarks</b><br>Overall Interior - Animal Hair - Yes / (R) Front Seat - Grime - Large / (L) Front Seat - Grime - Medium / (L) Front Floor Mat - Worked - Small / Rear Seat - Grime - Medium / Dashboard - Traces of Adhesive Tape - Yes / Overall Interior - Smell - Yes | <b>Remarks</b><br>(L) Mirror - Scratch - Small / Front Bumper, Grille, Lamps - Repair mark - Yes / Front Bumper, Grille, Lamps - Scratch - Large / (L) Rear Door, Molding - Dent - Small / Trunk Hood, Rear Gate - Scratch & Dent - Medium / Rear Bumper, Lamps, Panels - Scratch & Dent - Medium / (R) Mirror - Scratch - Small / (R) Front Door, Molding - Dent - Small / (L) Rear Door, Molding - Repair mark - Yes / (L) Rear Fender, Molding - Dent - Small / (R) Step, In-panel, Side Spoiler - Scratch - Minimal |
