## General Information

| Make | Toyota | Model | Vios |

## Body / Panel Condition

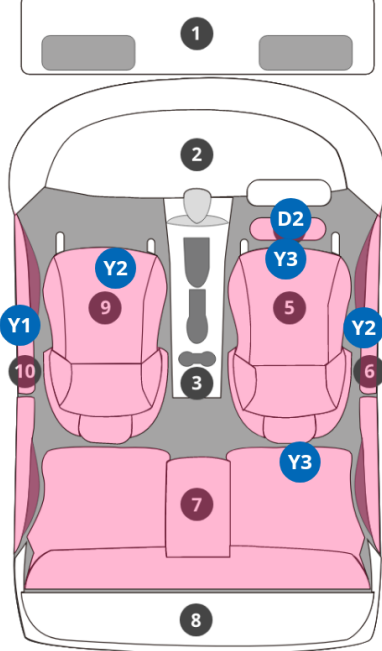
| Interior Evaluation : <b>B</b> | Exterior Evaluation : <b>C</b> |
| <b>Remarks</b><br>(R) Front Seat - Grime - Medium / (L) Front Seat - Grime - Small / (L) Front Floor Mat - Worked - Small / Rear Seat - Grime - Medium / (R) Front Trim - Grime - Small / (L) Front Trim - Grime - Minimal | <b>Remarks</b><br>(R) Mirror - Scratch - Small / (R) Front Door, Molding - Scratch & Dent - Medium / Rear Bumper, Lamps, Panels - Scratch - Small / Trunk Hood, Rear Gate - Dent - Small / (L) Mirror - Scratch - Minimal / (L) Front Door, Molding - Scratch - Minimal / (L) Rear Door, Molding - Scratch & Dent - Small / (L) Front Fender, Molding - Scratch - Medium / Front Bumper, Grille, Lamps - Scratch & Dent - Large / Member (Bolted) - Dent - Yes / Roof - Scratch - Minimal |
