## General Information

| Make | Toyota | Model | Vios |
| Registration No. | NGL9550 | Chassis No. | PA1B18F38M4138572 |

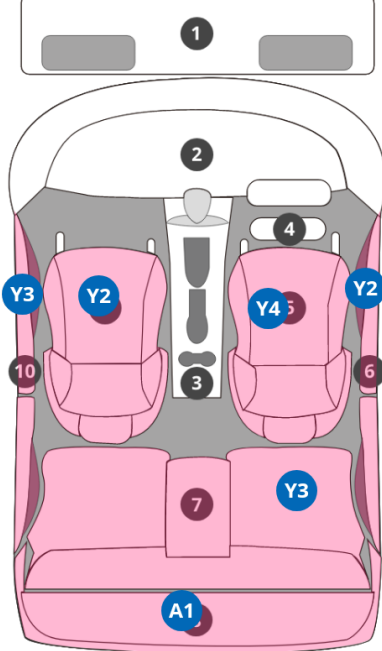
| Interior Evaluation : <span style="color: red;">C</span> | Exterior Evaluation : <span style="color: red;">D</span> |
|---|---|
| <p><b>Remarks</b></p> <p>(R) Front Seat - Grime - Large / Rear Seat - Grime - Medium / (L) Front Seat - Grime - Small / (L) Front Trim - Grime - Medium / Trunk Room - Worn, Scratch, Cut, Crack - Minimal / (R) Front Trim - Grime - Small</p> | <p><b>Remarks</b></p> <p>Rear Bumper, Lamps, Panels - Scratch &amp; Dent - Medium / (R) Rear Fender, Molding - Scratch &amp; Dent - Medium / (R) Rear Door, Molding - Scratch &amp; Dent - Small / (R) Step, In-panel, Side Spoiler - Scratch &amp; Dent - Large / (R) Front Door, Molding - Scratch &amp; Dent - Small / Bonnet, Headlight - Dent - Medium / Front Bumper, Grille, Lamps - Scratch - Medium / (L) Front Fender, Molding - Dent - Small / (L) Front Door, Molding - Scratch - Minimal / (L) Rear Fender, Molding - Scratch - Small / (L) Rear Door, Molding - Scratch - Minimal / Roof - Scratch - Small</p> |
