## General Information

| Make | Toyota | Model | Wigo |
| YOM | 2021 | Mileage | 46,915 |

## Body / Panel Condition

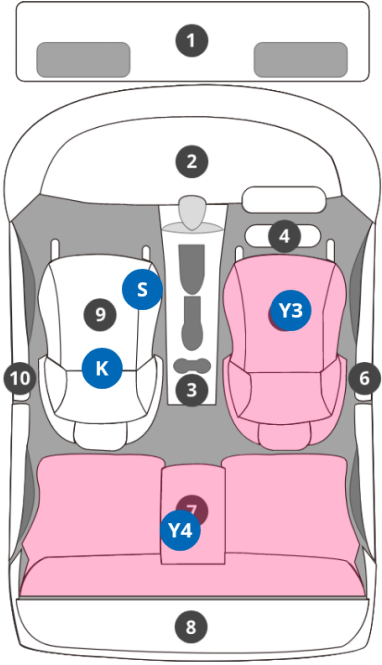
| Interior Evaluation : <span style="color: red;">C</span> | Exterior Evaluation : <span style="color: red;">E</span> |
|---|---|
| <b>Remarks</b><br>Overall Interior - Smell - Yes / Overall Interior - Animal Hair - Yes / (R) Front Seat - Grime - Medium / Rear Seat - Grime - Large | <b>Remarks</b><br>Bonnet - Repair Traces - Yes / (L) Rear Door - Repair Traces - Yes / (L) Rear Fender - Repair Traces - Yes / Rear Bumper, Lamps, Panels - Repair mark - Yes / Rear Bumper, Lamps, Panels - Crack, Gap - Large / (L) Rear Door, Molding - Scratch - Small / (L) Front Door, Molding - Scratch - Medium / (L) Front Fender, Molding - Scratch - Medium / Bonnet, Headlight - Scratch - Large / Front Bumper, Grille, Lamps - Scratch & Dent - Large / (R) Front Door, Molding - Dent - Small / (R) Step, In-panel, Side Spoiler - Scratch & Dent - Small / (R) Rear Door, Molding - Scratch - Small / (R) Mirror - Scratch - Small / (L) Mirror - Scratch - Small / Roof - Dent - Small / (R) Rear Fender, Molding - Scratch & Dent - Small |
