## General Information

| Make | Toyota | Model | Rush |
| YOM | 2020 | Mileage | 51,250 |

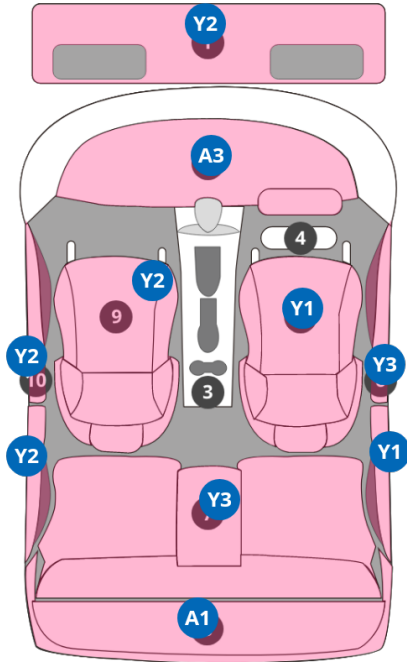
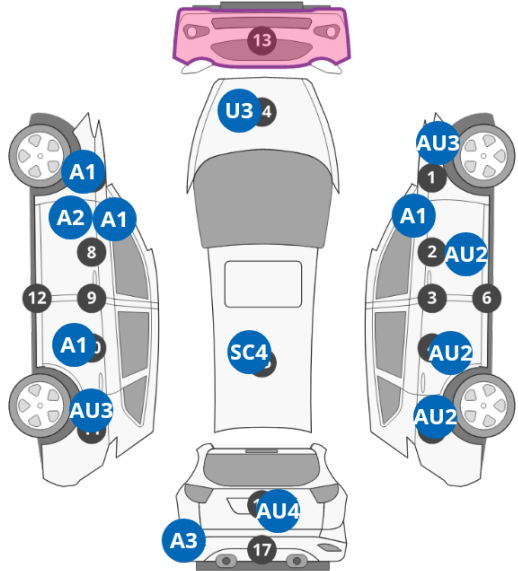
| Interior Evaluation : <span style="color: red;">C</span> | Exterior Evaluation : <span style="color: red;">E</span> |
|---|---|
| <b>Remarks</b><br>Trunk Room - Worn, Scratch, Cut, Crack - Minimal / (R) Front Trim - Grime - Medium / (R) Front Seat - Grime - Minimal / Rear Seat - Grime - Medium / (R) Rear Trim - Grime - Minimal / (L) Rear Trim - Grime - Small / (L) Front Trim - Grime - Small / Ceiling - Grime - Small / (L) Front Seat - Grime - Small / Steering Wheel - Worn, Peel, Crack - Medium | <b>Remarks</b><br>(R) Front Fender, Molding - Scratch & Dent - Medium / (R) Front Door, Molding - Scratch & Dent - Small / (R) Mirror - Scratch - Minimal / (R) Rear Door, Molding - Scratch & Dent - Small / (R) Rear Fender, Molding - Scratch & Dent - Small / Rear Bumper, Lamps, Panels - Scratch - Medium / Trunk Hood, Rear Gate - Scratch & Dent - Large / (L) Rear Fender, Molding - Scratch & Dent - Medium / (L) Rear Door, Molding - Scratch - Minimal / (L) Mirror - Scratch - Minimal / (L) Front Door, Molding - Scratch - Small / (L) Front Fender, Molding - Scratch - Minimal / Front Bumper, Grille, Lamps - Repair mark - Difference in Color / Bonnet, Headlight - Dent - Medium / Roof - Rust, Corrosion - Large |

| Inspector Notes |
|---|
| with LTO plate, no warranty booklet, with jack, no tools, with spare tire, cracked left side mirror, right fog lamp cover missing, front bumper difference in color, plate light issue |
