## General Information

| Make | Toyota | Model | Vios |
| YOM | 2023 | Mileage | 74,943 |
| Registration No. | NHI7499 | Chassis No. | PA1B18F35P4207822 |

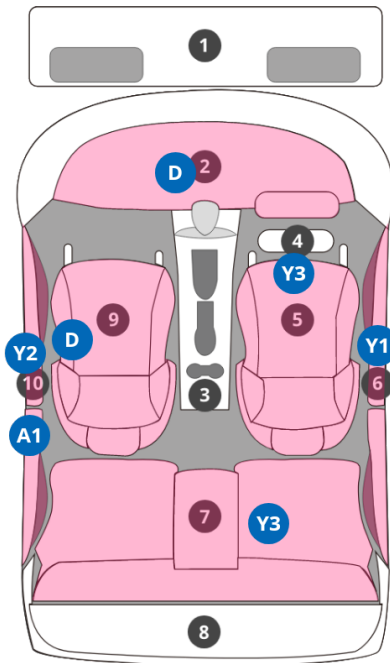
| Interior Evaluation : <b>B</b> | Exterior Evaluation : <b>C</b> |
|---|---|
| <p><b>Remarks</b></p> <p>Rear Seat - Grime - Medium / (R) Front Seat - Grime - Medium / (R) Front Trim - Grime - Minimal / (L) Rear Trim - Cut, Crack - Minimal / (L) Front Trim - Grime - Small / Dashboard - Traces of Adhesive Tape - Yes / (L) Front Seat - Worn - Yes</p> | <p><b>Remarks</b></p> <p>(R) Mirror - Scratch - Minimal / (R) Front Door, Molding - Scratch - Small / (R) Rear Door, Molding - Scratch &amp; Dent - Small / Rear Bumper, Lamps, Panels - Scratch - Small / Trunk Hood, Rear Gate - Scratch &amp; Dent - Minimal / (L) Rear Fender, Molding - Dent - Minimal / (L) Rear Door, Molding - Scratch - Small / (L) Step, In-panel, Side Spoiler - Scratch - Minimal / (L) Front Door, Molding - Scratch - Small / (L) Mirror - Scratch - Minimal / (L) Front Fender, Molding - Scratch - Minimal / Front Bumper, Grille, Lamps - Scratch &amp; Dent - Medium / Roof - Scratch - Small</p> |
