## General Information

<b>Make</b>	Nissan	<b>Model</b>	Terra
<b>YOM</b>	2020	<b>Mileage</b>	56,406
<b>Registration No.</b>	LAI6204	<b>Chassis No.</b>	MNTJCAD23Z0016380
<b>CC</b>	2.5	<b>Transmission</b>	A/T
<b>Fuel Type</b>	Diesel	<b>Type of Body</b>	SUV
<b>Colour</b>	White

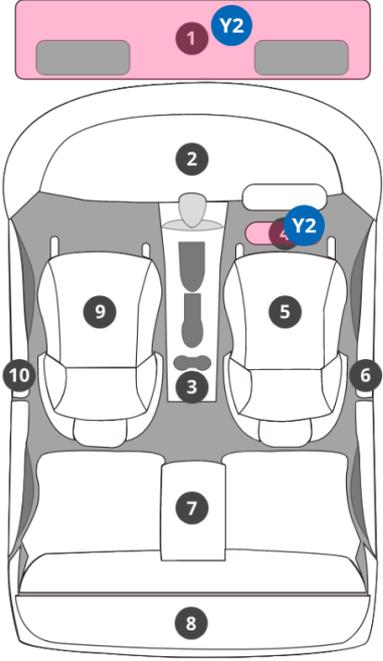
<b>Interior Evaluation :</b> <span style="float: right; color: red; font-weight: bold;">A</span>	<b>Exterior Evaluation :</b> <span style="float: right; color: red; font-weight: bold;">C</span>

<p><b>a</b> : Cut, Fray <b>d</b> : Loose, Deformed <b>k</b> : Animal Hair <b>s</b> : Smell <b>t</b> : Cigarette Burns <b>x</b> : Defective <b>y</b> : Stain</p>

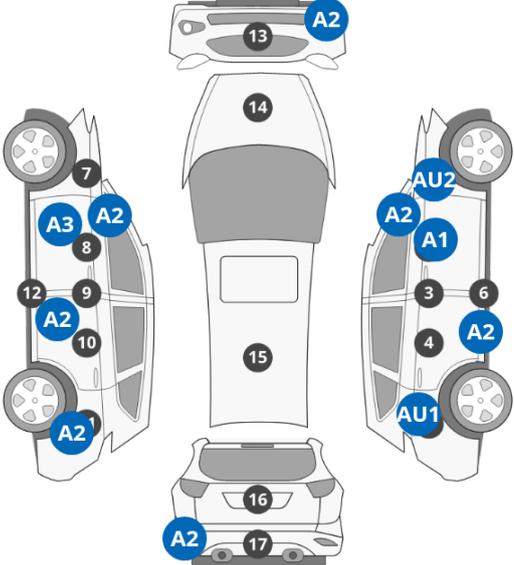
<p><b>A</b> : Scratch <b>AU</b> : Scratch &amp; Dent <b>B</b> : Modified <b>C</b> : Corrosion <b>G</b> : Stone chip <b>P</b> : Faded <b>S</b> : Rust <b>SC</b> : Rust &amp; Corrosion <b>U</b> : Dent <b>X</b> : Defective <b>Y</b> : Crack, Gap</p>
<p><b>Remarks</b> (R) Front Floor Mat - Grime - Small / Ceiling - Grime - Small</p>	<p><b>Remarks</b> Bonnet - Repair Traces - Yes / (L) Mirror - Scratch - Small / (L) Rear Fender, Molding - Scratch - Small / Rear Bumper, Lamps, Panels - Scratch - Small / (L) Rear Door, Molding - Scratch - Small / (L) Front Door, Molding - Scratch - Medium / Front Bumper, Grille, Lamps - Scratch - Small / (R) Front Fender, Molding - Scratch &amp; Dent - Small / (R) Front Door, Molding - Scratch - Minimal / (R) Mirror - Scratch - Small / (R) Rear Fender, Molding - Scratch &amp; Dent - Minimal / (R) Step, In-panel, Side Spoiler - Scratch - Small</p>
