General Information

Make	Suzuki	Model	Dzire
YOM	2022	Mileage	45,045
Registration No.	FAI7944	Chassis No.	MBHZF63B4NG156413
CC	1.2	Transmission	A/T
Fuel Type	Gas	Type of Body	Sedan
Colour	Brown

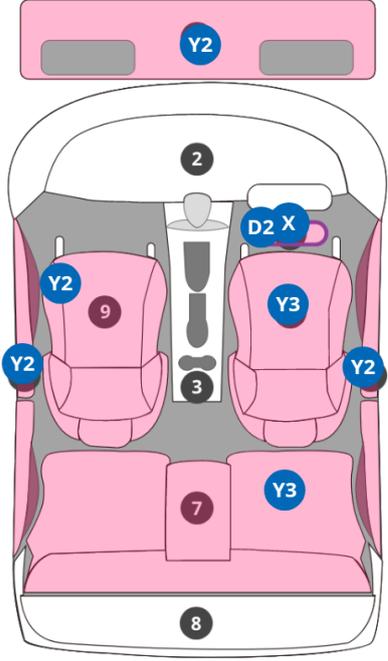
Interior Evaluation : B	Exterior Evaluation : D

<p>a : Cut, Fray d : Loose, Deformed k : Animal Hair s : Smell t : Cigarette Burns x : Defective y : Stain</p>

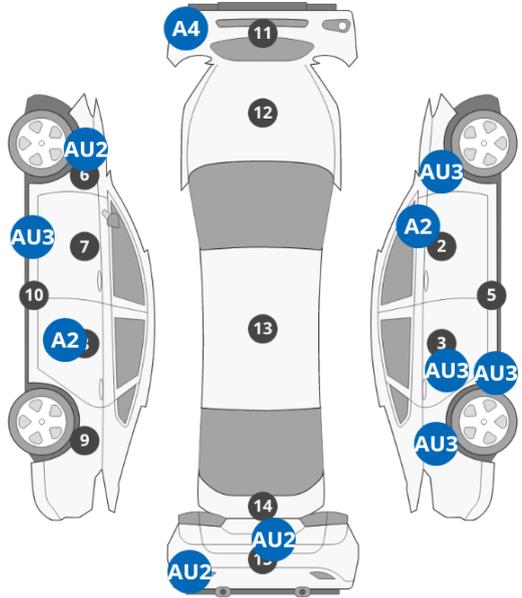
<p>A : Scratch AU : Scratch & Dent B : Modified C : Corrosion G : Stone chip P : Faded S : Rust SC : Rust & Corrosion U : Dent X : Defective Y : Crack, Gap</p>
<p>Remarks Mat Other - Missing - Yes / Ceiling - Grime - Small / (R) Front Trim - Grime - Small / (R) Front Seat - Grime - Medium / Rear Seat - Grime - Medium / (L) Front Trim - Grime - Small / (L) Front Seat - Grime - Small / (L) Front Floor Mat - Worked - Small</p>	<p>Remarks (R) Step, In-panel, Side Spoiler - Scratch & Dent - Medium / (R) Rear Door, Molding - Scratch & Dent - Medium / (R) Rear Fender, Molding - Scratch & Dent - Medium / Trunk Hood, Rear Gate - Scratch & Dent - Small / Rear Bumper, Lamps, Panels - Scratch & Dent - Small / (L) Rear Door, Molding - Scratch - Small / (L) Step, In-panel, Side Spoiler - Scratch & Dent - Medium / (L) Front Fender, Molding - Scratch & Dent - Small / (R) Front Fender, Molding - Scratch & Dent - Medium / Front Bumper, Grille, Lamps - Scratch - Large / (R) Mirror - Scratch - Small</p>
