## General Information

| Make | Mitsubishi | Model | Mirage |
| YOM | 2023 | Mileage | 29,545 |
| Registration No. | DBG5009 | Chassis No. | PAEA13TJPNA000185 |

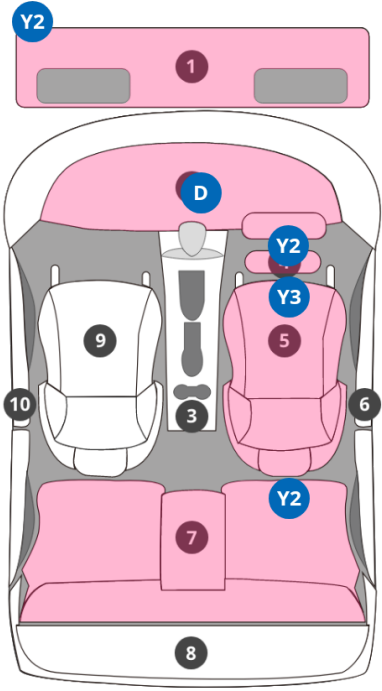
| <b>Interior Evaluation :</b> <b>B</b> | <b>Exterior Evaluation :</b> <b>B</b> |
| <b>Remarks</b><br>Mat Other - Grime - Small / Rear Seat - Grime - Small / (R) Front Seat - Grime - Medium / Dashboard - Traces of Adhesive Tape - Yes / Ceiling - Grime - Small | <b>Remarks</b><br>(R) Rear Fender - Repair Traces - Yes / (R) Rear Door - Repair Traces - Yes / (L) Rear Fender, Molding - Scratch & Dent - Medium / (L) Front Door, Molding - Dent - Medium / (L) Rear Door, Molding - Scratch - Minimal / (L) Front Fender, Molding - Scratch - Minimal / Front Bumper, Grille, Lamps - Scratch - Medium / Front Bumper, Grille, Lamps - Repair mark - Yes / (R) Mirror - Scratch - Minimal / Rear Bumper, Lamps, Panels - Scratch - Minimal |
