General Information

Make	Hyundai	Model	Reina
YOM	2019	Mileage	51,447
Registration No.	NFW2335	Chassis No.	LBECBADB5LW083223
CC	1.4	Transmission	A/T
Fuel Type	Gas	Type of Body	Sedan
Colour	Brown

Body / Panel Condition

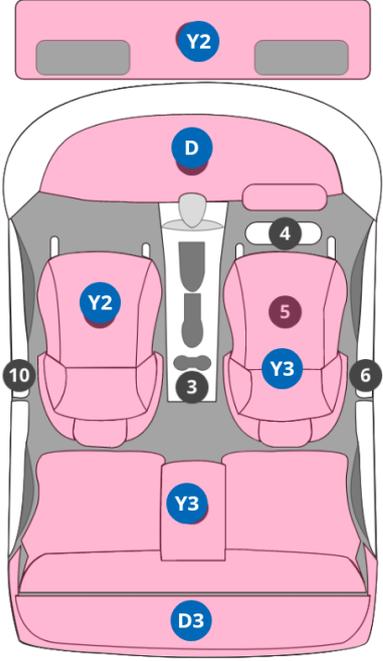
Interior Evaluation : A	Exterior Evaluation : D

<p>a : Cut, Fray d : Loose, Deformed k : Animal Hair s : Smell t : Cigarette Burns x : Defective y : Stain</p>

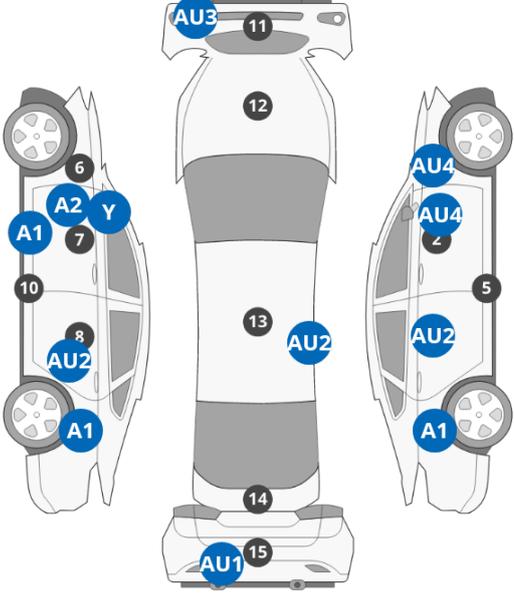
<p>A : Scratch AU : Scratch & Dent B : Modified C : Corrosion G : Stone chip P : Faded S : Rust SC : Rust & Corrosion U : Dent X : Defective Y : Crack, Gap</p>
Remarks Defects not found	Remarks (L) Rear Door, Molding - Scratch & Dent - Small / (R) Front Fender, Molding - Scratch & Dent - Large / (R) Front Door, Molding - Scratch & Dent - Large / (R) Rear Door, Molding - Scratch & Dent - Small / (R) Rear Fender, Molding - Scratch - Minimal / Rear Bumper, Lamps, Panels - Scratch & Dent - Minimal / (L) Step, In-panel, Side Spoiler - Scratch - Minimal / (L) Front Door, Molding - Scratch - Small / (L) Rear Fender, Molding - Scratch - Minimal / Roof - Scratch & Dent - Small / Front Bumper, Grille, Lamps - Scratch & Dent - Medium / (L) Mirror - Crack - Damaged
